A down-hole static video survey was performed by BESSST, Inc. inside Sheep Creek Well 3A on July 24th, 2018. The video survey was performed using a miniaturized camera, measuring 0.75" OD and configured for color imaging. The focus of the investigation was to evaluate the condition of the well screen throughout the perforated section to determine the potential cause(s) of production losses; as well as to use the video data to formulate potential remedies for remediating the problem. The intent of the survey was to reach the bottom of the well, located at 500 Ft. BGS, this was not possible due to sediment fill that blocked the camera survey to reach the bottom of the well. As a result, the survey was completed to a depth of 494 Ft. BGS

A down-hole static video survey was performed by BESSST, Inc. inside Sheep Creek Well 4A on July 24th, 2018. The video survey was performed using a miniaturized camera, measuring 0.75" OD and configured for color imaging. The focus of the investigation was to evaluate the condition of the well screen throughout the perforated section to determine the potential cause(s) of production losses, as well as to use the video data to formulate potential reme

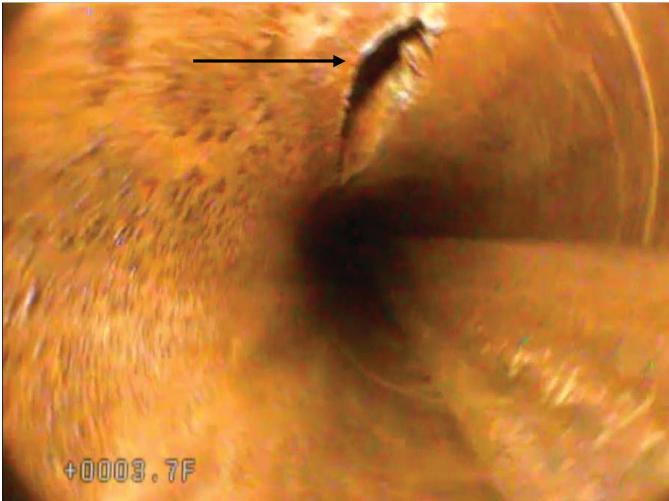
Pumping Rate (GPM)	Depth (Ft. BGS)	Video Time (hh:mm:ss)	Image & Description
Static conditions	3.7 Ft. BGS	00:00:09

<p>Large gash present in the well casing at the top of the casing. Because of the size of the gash, and its location above the water level, it is unlikely to have been caused by corrosion. Most likely, the gash was created during the installation of the pump into the well when the well was drilled.</p>

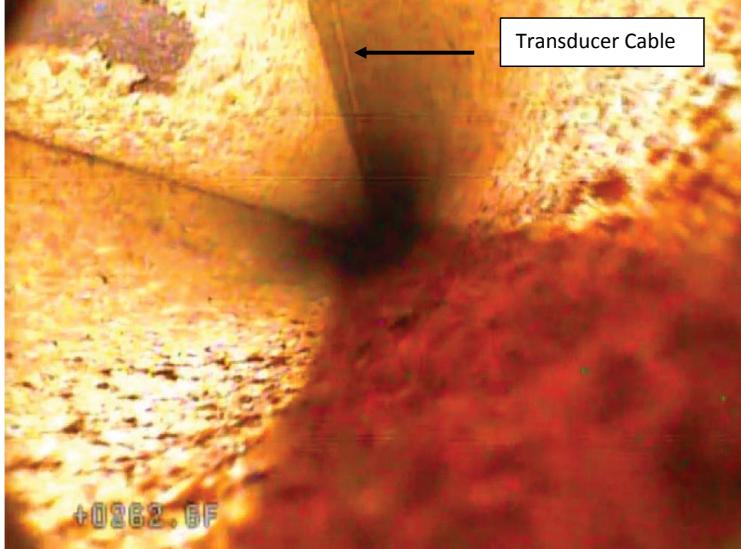
Pumping Rate (GPM)	Depth (Ft. BGS)	Video Time (hh:mm:ss)	Image & Description
Static conditions	262.6 Ft. BGS	00:12:32

<p>Heavy rust on casing and pump column. Flaking of rust material from the pump column can be seen. Transducer cable visible.</p>

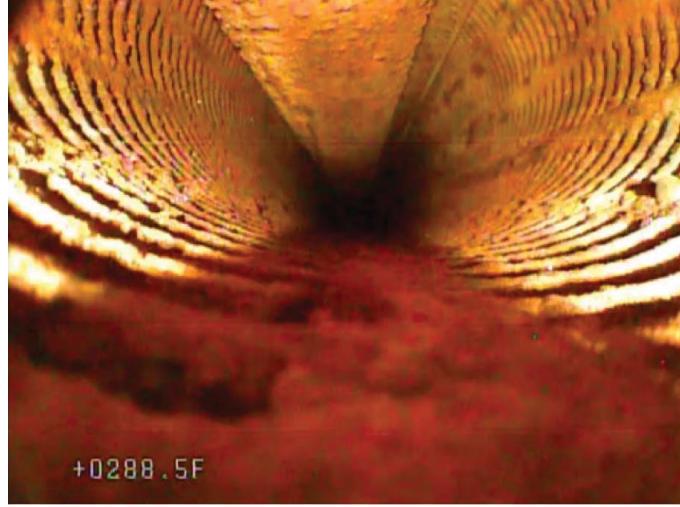
Pumping Rate (GPM)	Depth (Ft. BGS)	Video Time (hh:mm:ss)	Image & Description
Static Conditions	288.5 Ft. BGS	00:15:52

<p data-bbox="572 1241 1486 1296">Top of screen above static water level. 31.5 Ft. of louvered well screen is exposed above the static water level.</p>

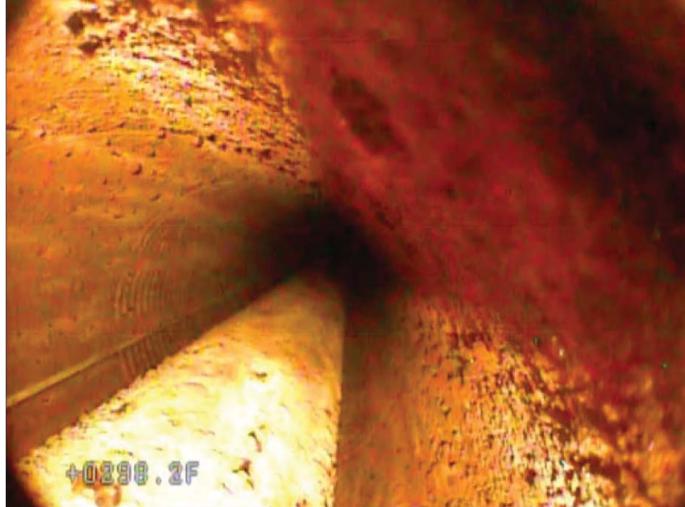
Pumping Rate (GPM)	Depth (Ft. BGS)	Video Time (hh:mm:ss)	Image & Description
Static conditions	298.2 Ft. BGS	00:16:29

<p data-bbox="605 1290 1462 1353">Welded casing joint in well screen indicates that well screen was installed in 10 Ft. sections. Transducer cable still visible.</p>

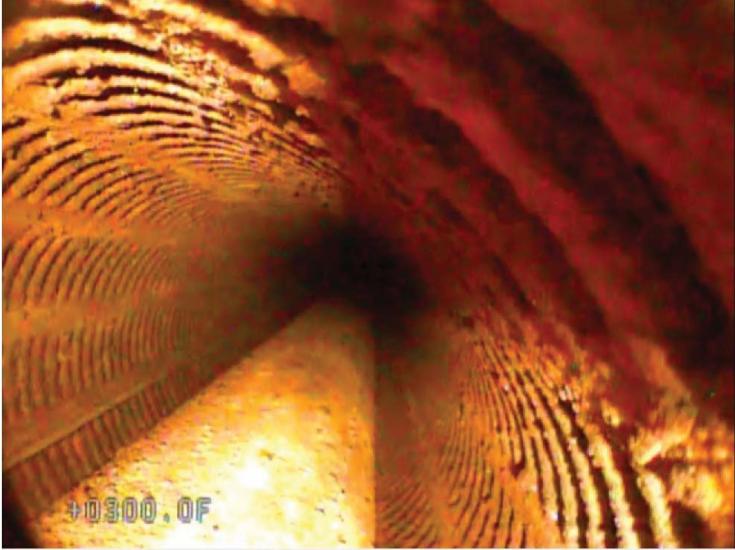
Pumping Rate (GPM)	Depth (Ft. BGS)	Video Time (hh:mm:ss)	Image & Description
Static conditions	300 Ft. BGS	00:17:29

<p data-bbox="698 1262 1367 1294">Screen continues above static water level. Transducer cable still visible.</p>

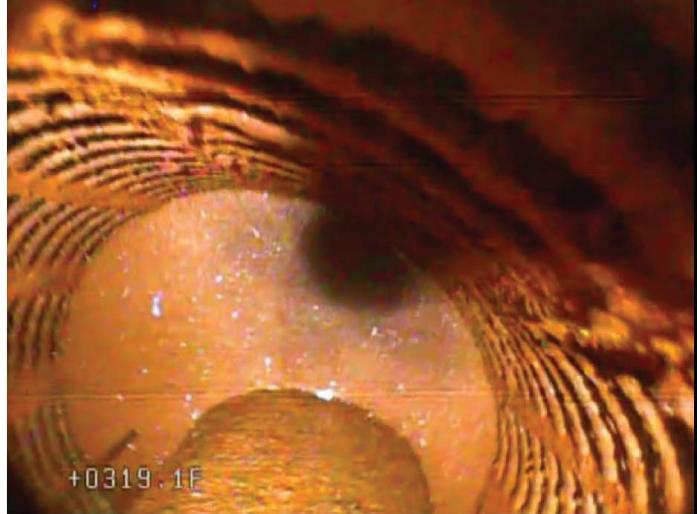
Pumping Rate (GPM)	Depth (Ft. BGS)	Video Time (hh:mm:ss)	Image & Description
Static conditions	319.1 Ft. BGS	00:18:53

<p data-bbox="567 1269 1498 1332">Static water level. Photo still from 319.1 Ft.BGS. Actual static water level was measured at 320.1 Ft. BGS.</p>

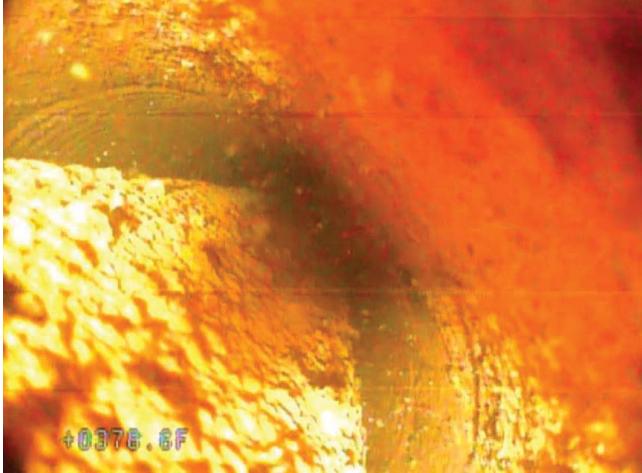
Pumping Rate (GPM)	Depth (Ft. BGS)	Video Time (hh:mm:ss)	Image & Description
Static conditions	378.6 Ft. BGS	00:23:27

<p data-bbox="567 1241 1503 1298">Second welded casing joint in well screen. Transducer not visible at this depth. Heavy build up along well screen, but louver openings are still easily visible.</p>

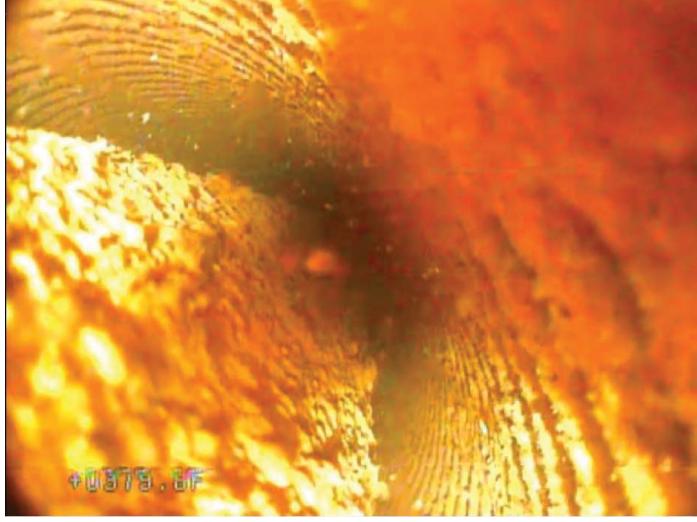
Pumping Rate (GPM)	Depth (Ft. BGS)	Video Time (hh:mm:ss)	Image & Description
Static conditions	379.8 Ft. BGS	00:23:50

<p data-bbox="719 1256 1346 1290">Screen continues, and transducer cable is not visible at this depth.</p>

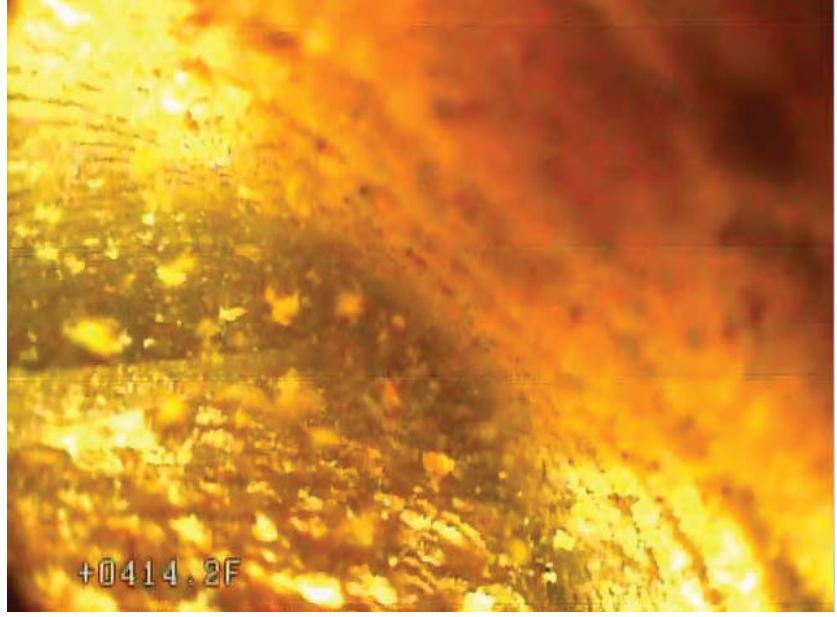
Pumping Rate (GPM)	Depth (Ft. BGS)	Video Time (hh:mm:ss)	Image & Description
Static conditions	414.2 Ft. BGS	00:32:08

<p data-bbox="612 1320 1449 1436">+0414.2F</p> <p data-bbox="796 1347 1269 1374">Material build up on screen increases with depth.</p>

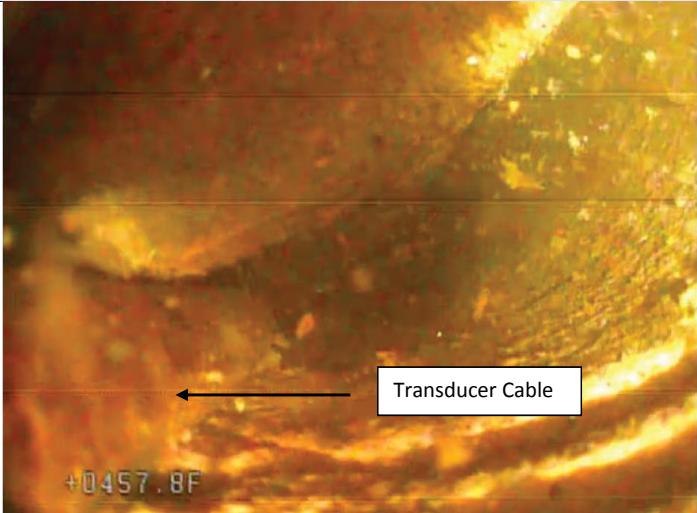
Pumping Rate (GPM)	Depth (Ft. BGS)	Video Time (hh:mm:ss)	Image & Description
Static conditions	457.8 Ft. BGS	00:36:28

<p>A color underwater photograph showing the interior of a large cylindrical structure, likely a pump bowl. The water is dark and reflects the light from the camera. A horizontal pipe or cable runs across the upper portion of the frame. A white callout box with a black arrow points to this pipe, labeled "Transducer Cable". In the bottom left corner of the image, there is a digital readout that says "+0457.8F".</p> <p>Top of pump bowls. Housing pipe where transducer cable ends.</p>

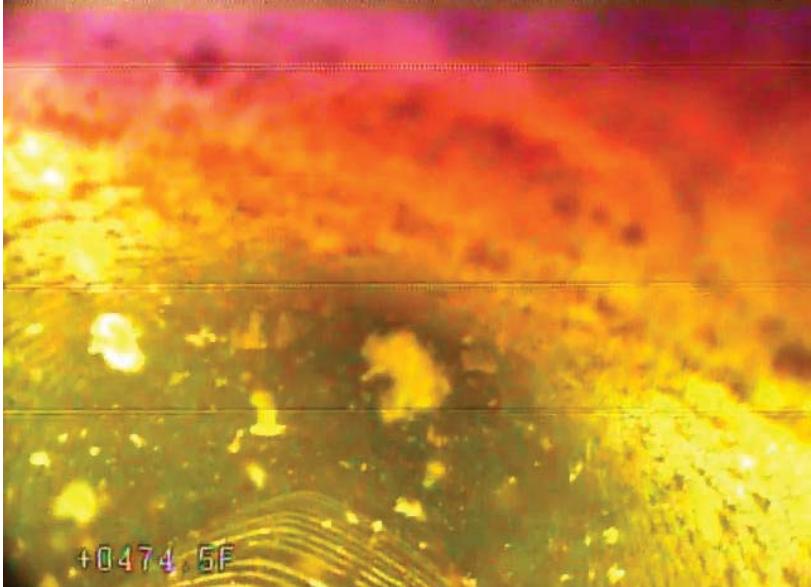
Pumping Rate (GPM)	Depth (Ft. BGS)	Video Time (hh:mm:ss)	Image & Description
Static conditions	474.5 Ft. BGS	00:38:42

<p data-bbox="931 1326 1132 1353">Top of cone strainer</p>

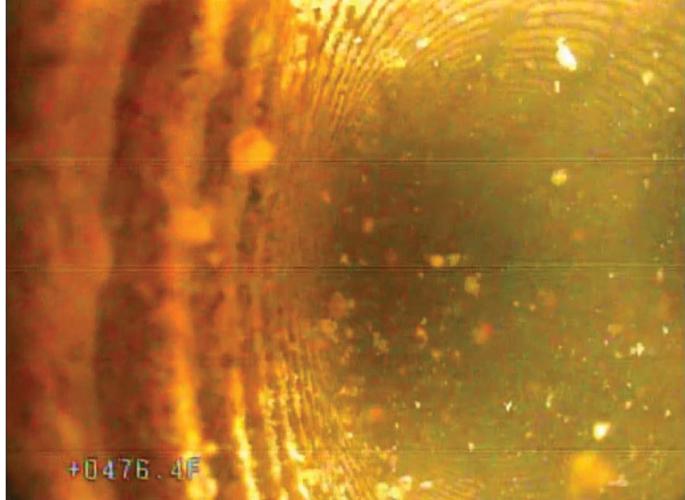
Pumping Rate (GPM)	Depth (Ft. BGS)	Video Time (hh:mm:ss)	Image & Description
Static conditions	476.4 Ft. BGS	00:38:59

<p data-bbox="768 1227 1302 1258">Bottom of cone strainer (shadow on right side of image).</p>

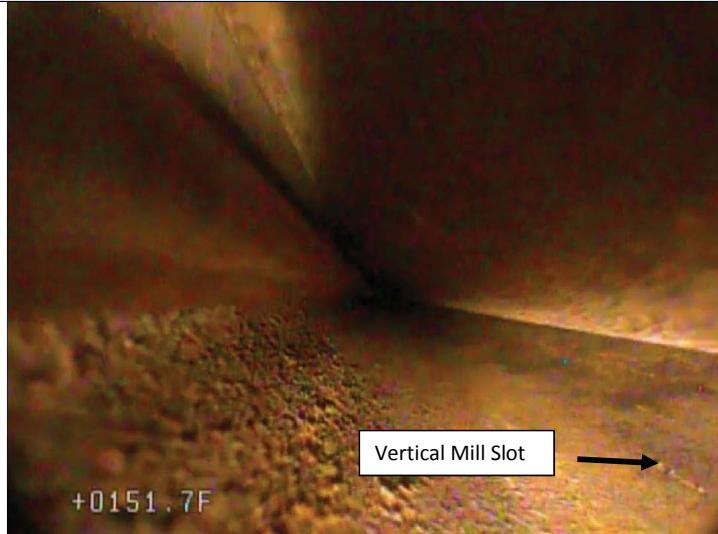
Pumping Rate (GPM)	Depth (Ft. BGS)	Video Time (hh:mm:ss)	Image & Description
Static conditions	151.7 Ft. BGS	00:8:51

<p>First slots observed in the screen, screen may start sooner but could not be seen (arrow where slot was visible). Instrument tube can be seen on left side of image.</p>

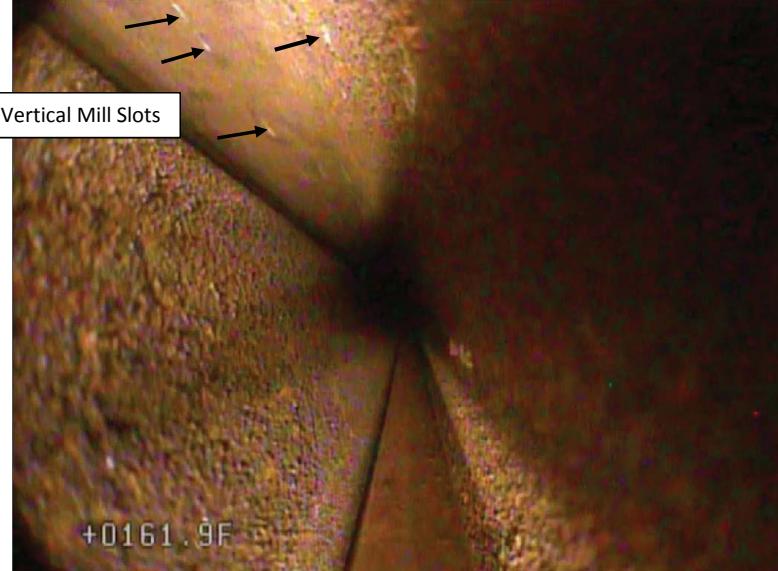
Pumping Rate (GPM)	Depth (Ft. BGS)	Video Time (hh:mm:ss)	Image & Description
Static conditions	161.9 Ft. BGS	00:10:23

<p data-bbox="638 1347 1416 1379">Slots in screen are clearly visible (arrows where slots are visible).</p>

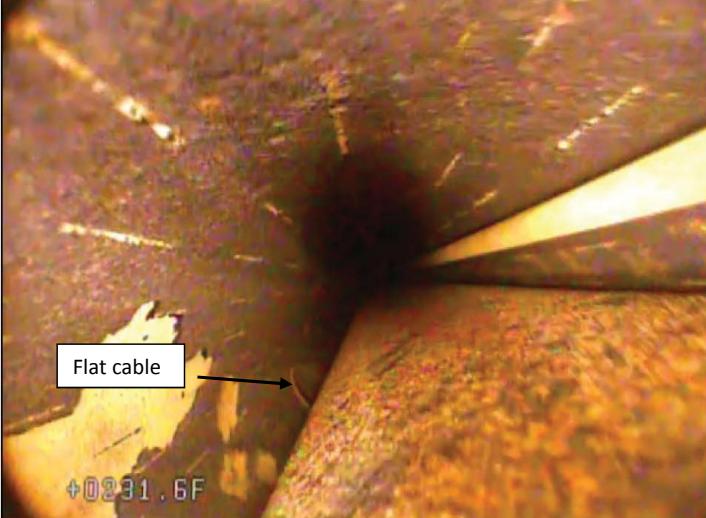
Pumping Rate (GPM)	Depth (Ft. BGS)	Video Time (hh:mm:ss)	Image & Description
Static conditions	231.6 Ft. BGS	00:18:36

<p>A close-up underwater photograph showing a textured, brownish-yellow rock surface. A white rectangular label with the text "Flat cable" is overlaid on the image, pointing to a thin, horizontal white line that appears to be a cable or pipe. The water is slightly turbulent, with some ripples and reflections. In the bottom left corner of the image, there is a digital timestamp "+0231.6F".</p> <p>Possibly starting point where scaling from hard water begins. Similar patches of scaling continue until 243.1 Ft. BGS were scaling becomes denser. A flat cable can be seen just below scaling. End of cable was not seen.</p>

A couple of other features observed inside well 4A include what appeared to be a portion of an instrument cable located from 231 to 243 Ft. BGS., and an instrument tube from the surface down to at least the top of the pump (at 438.8 Ft. BGS.). The cable appears to be white in color and flat in shape. A portion of the cable has been grown over by new iron oxide encrustations.

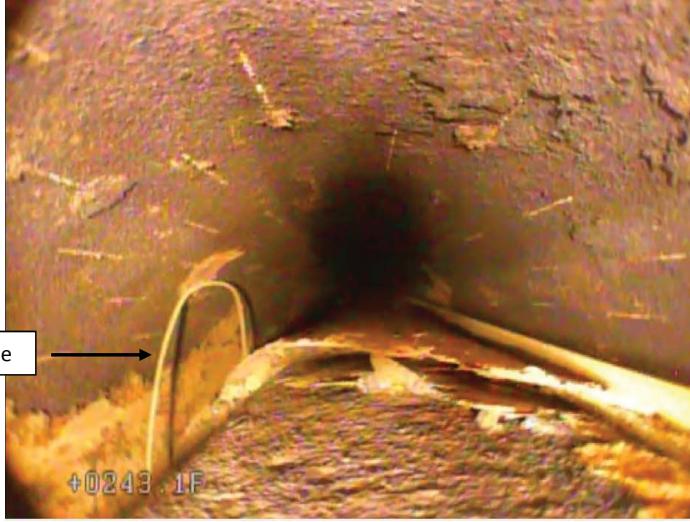
Pumping Rate (GPM)	Depth (Ft. BGS)	Video Time (hh:mm:ss)	Image & Description
Static conditions	243.1 Ft. BGS	00:19:42

<p data-bbox="682 1305 1388 1336">Hard water deposits continue in patches along casing. Flat cable still present.</p>

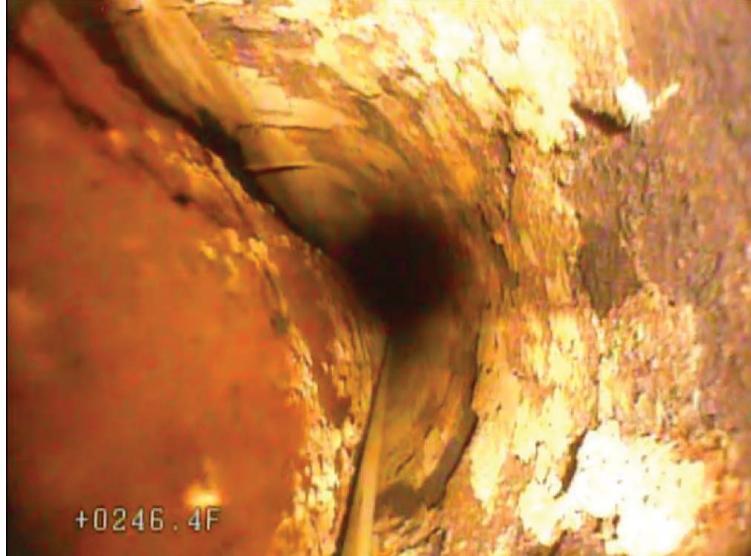
Pumping Rate (GPM)	Depth (Ft. BGS)	Video Time (hh:mm:ss)	Image & Description
Static conditions	246.4 Ft. BGS	00:21:19

<p data-bbox="829 1317 1237 1347">Hard water scaling starts to become dense.</p>

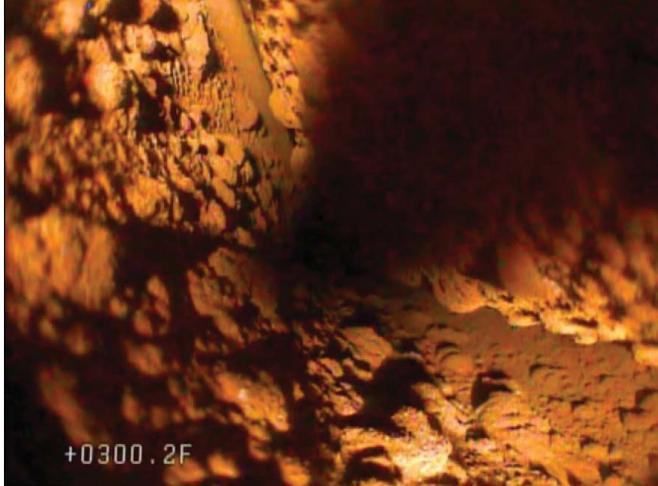
Pumping Rate (GPM)	Depth (Ft. BGS)	Video Time (hh:mm:ss)	Image & Description
Static conditions	300.2 Ft. BGS	00:25:13

<p data-bbox="845 1248 1217 1279">Hard water scaling increases in density.</p>

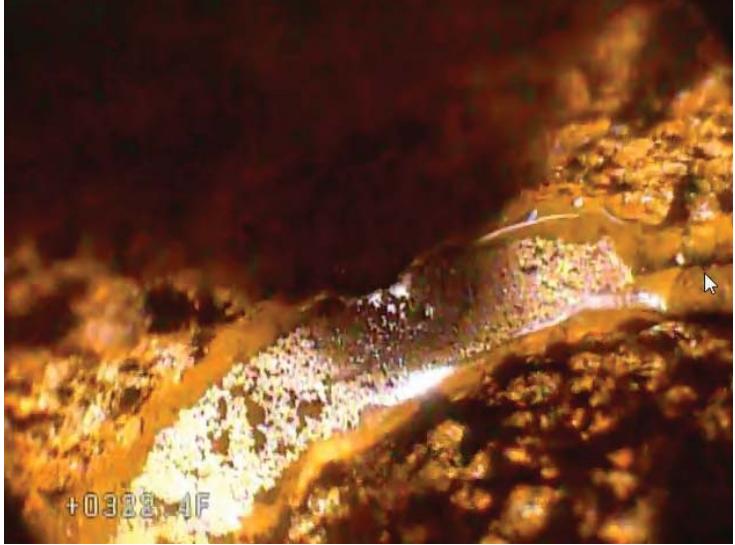
Pumping Rate (GPM)	Depth (Ft. BGS)	Video Time (hh:mm:ss)	Image & Description
Static conditions	322.4 Ft. BGS	00:28:47

<p>Static water level. Photo still from 322.4 Ft. BGS. Actual water level at 322.7 Ft. BGS.</p>

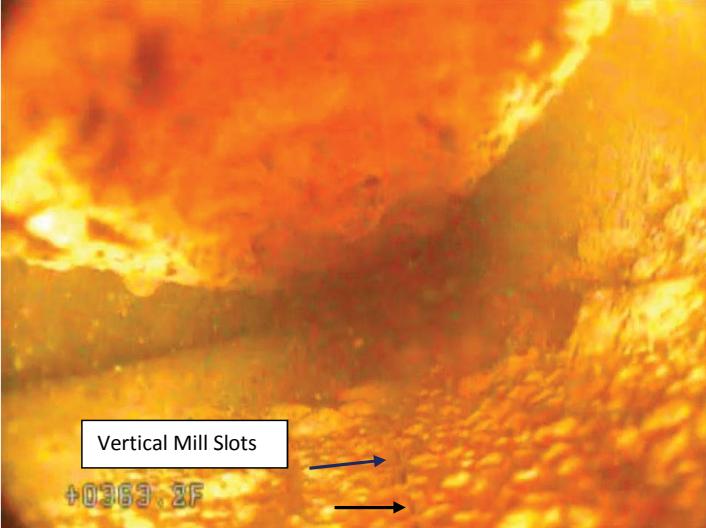
Pumping Rate (GPM)	Depth (Ft. BGS)	Video Time (hh:mm:ss)	Image & Description
Static conditions	363.2 Ft. BGS	00:35:31

<p data-bbox="677 1262 1383 1472"> Vertical Mill Slots +0363 . 2F </p> <p data-bbox="747 1290 1078 1248"> Slots in screen start to become visible again through scaling. </p>

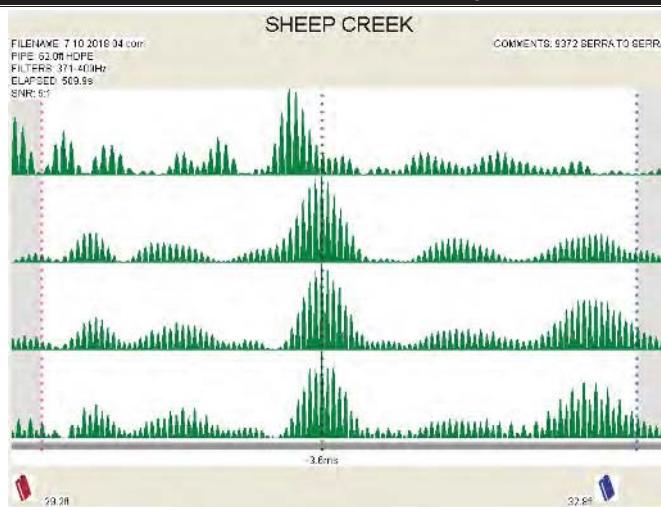
Survey #4

Leak located on Service Line Utility side.
