Sheep Creek Water Company
Preliminary Engineering Report
CRWA – Prop 1 Technical Assistance

Appendix E Leak Detection Report

Technical Assistance Leak Detection

Date:	7/10/2018-7/11/2018-7/13/2018
System:	Sheep Creek Water Company
Leak Detection members:	Abel Silva
Equipment Used:	FCS Correlator and FCS Acoustic Ground Mic
Map Reference:	Amigo Collect/GIS Map

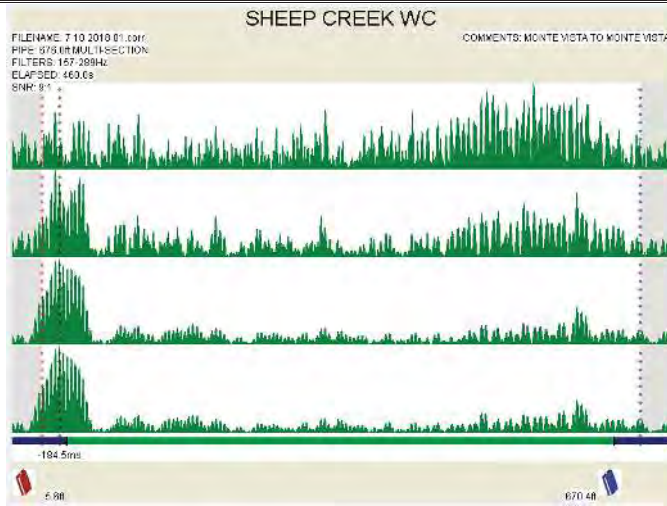
Survey #1

No leaks were found at time of survey.

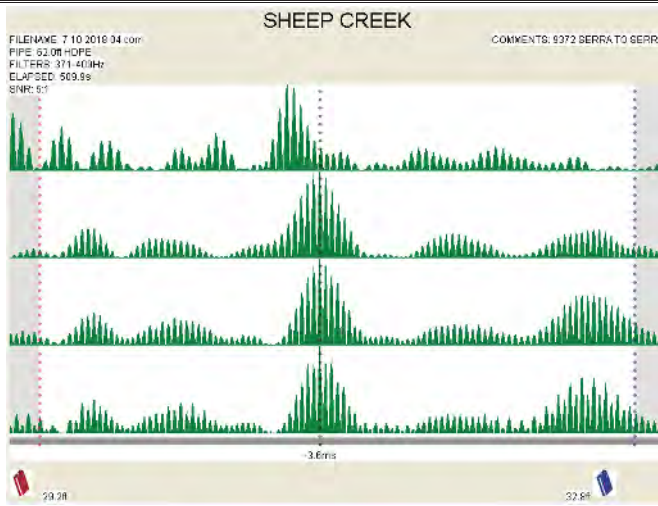
Survey #4

Leak located on Service Line Utility side.

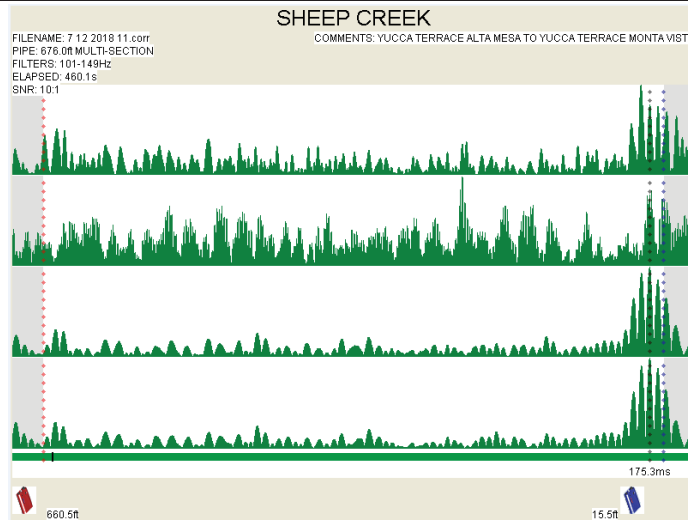
Survey #11

Possible leak 16' from intersection of Yucca Terrace / Monte Vista.
