**SAFE DRINKING WATER STATE REVOLVING FUND
APPLICANT ENGINEERING REPORT**

Water System Name: Sheep Creek Water Company

Project Number: 5207-A

Engineering Report Sheep Creek Water Company

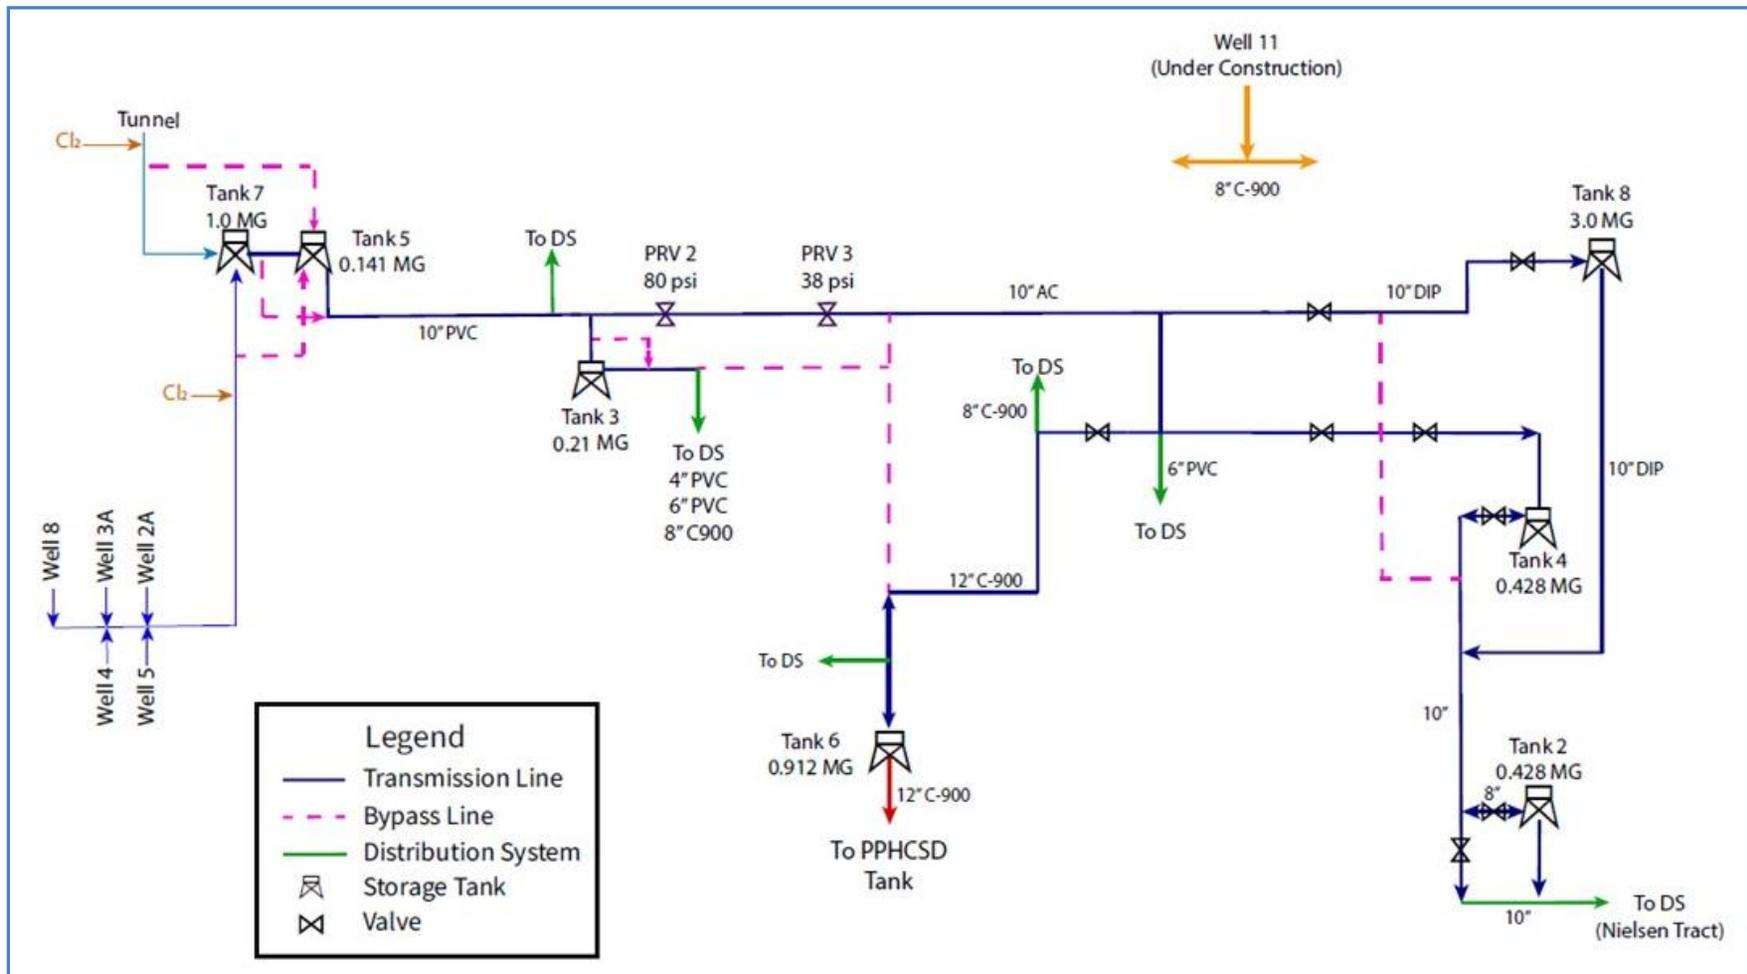
Figure 3: Flow diagram for Sheep Creek Water Company

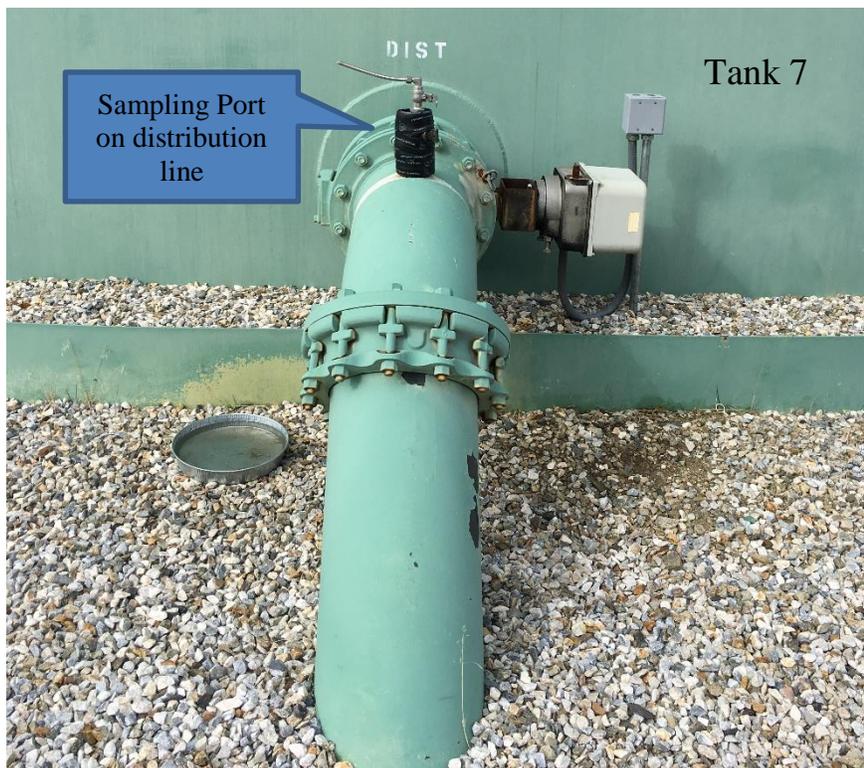
Figure 4: Chlorine sampling port on Tank 7

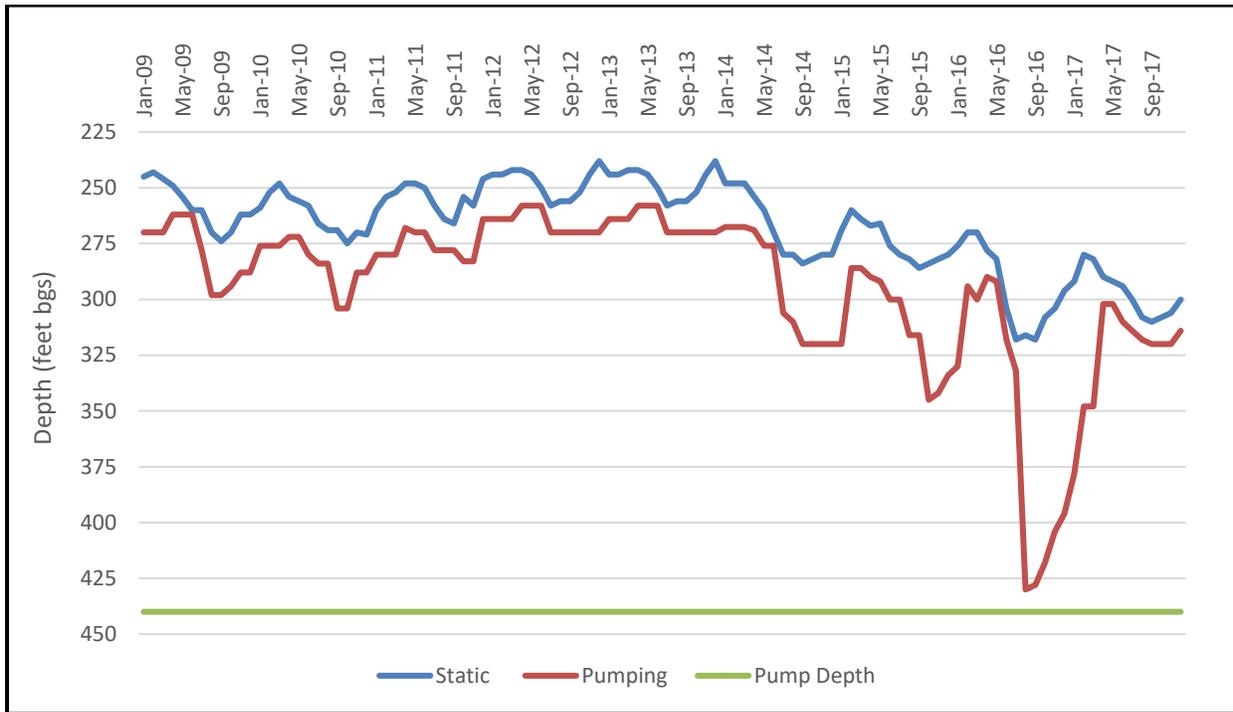
Figure 5 : Static and pumping groundwater levels for Well 4A

SCWC has experienced a steady decline in water production levels for the last 10 years. Swarthout Canyon, which is the primary source of water for the company, relies completely on run off from San Gabriel mountains and local precipitation for recharge, which has been insufficient due to drought conditions in California. Figure 5 shows the static and groundwater pumping water levels in one of the wells – Well 4A. As can be seen, the static groundwater level has fallen close to 50 feet from January, 2009 to December, 2017. The pumping water level has shown a similar trend. The most significant drop in the pumping water level was observed at the peak of drought in the summer of 2016, with the water level falling more than 100 feet, or within 10 feet of the pump depth. A similar curve for Well 8 is shown in Figure 6. Similar trends were also observed for the other wells.

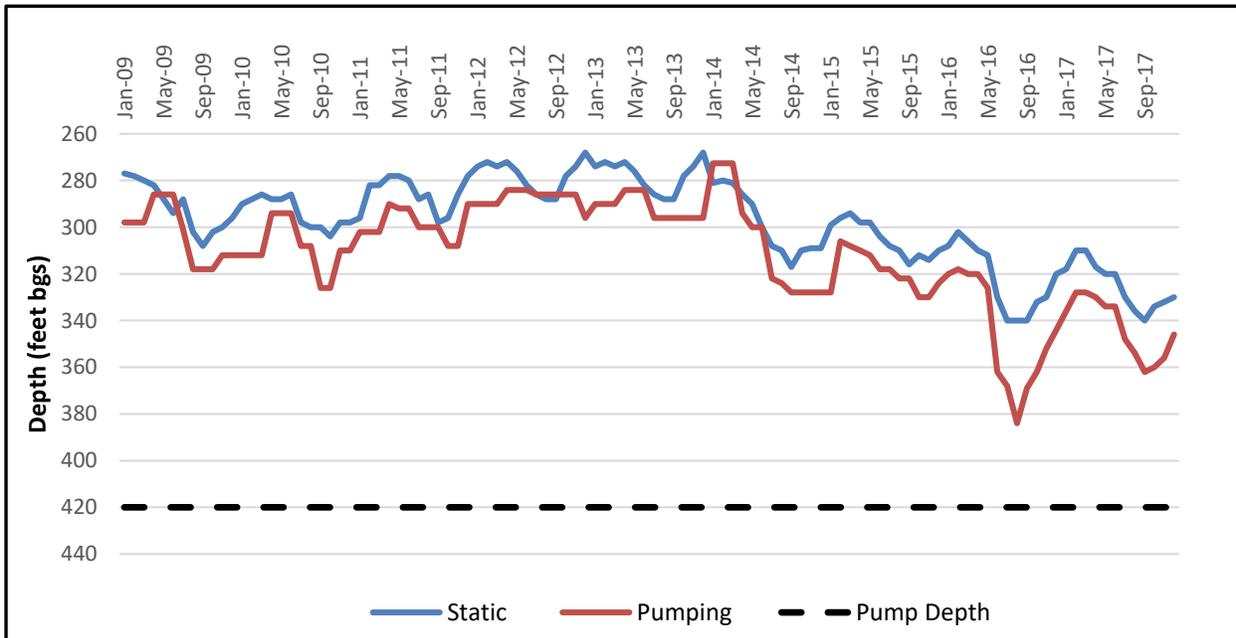
Figure 6 : Static and pumping groundwater levels for Well 8

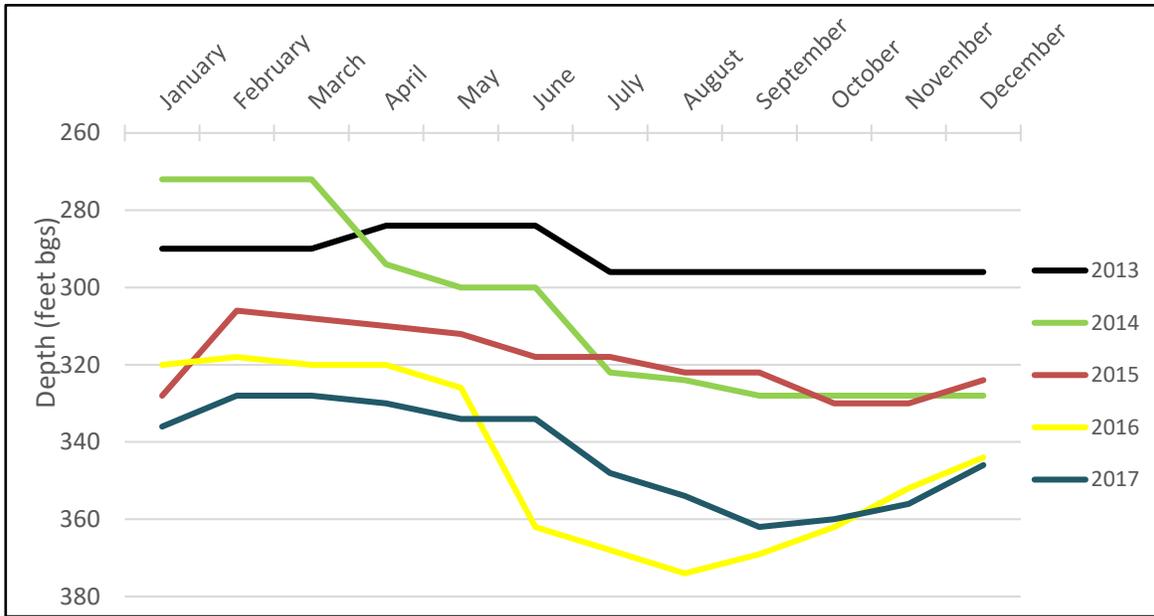
Figure 7 : Pumping water levels for Well 8

Figures 7 and 8 show the close correspondence between the declining water level and well production. Water level and production follow nearly parallel curves for each year graphed. As can be seen, the summer months of 2016 were the most critical time for the system. The water allocation per share was reduced at this time to reduce consumption. In addition, 4 MG of water was imported from PPHCSD to fulfil the demands of the system. Well 5 displays similar drop in production (Figure 9).

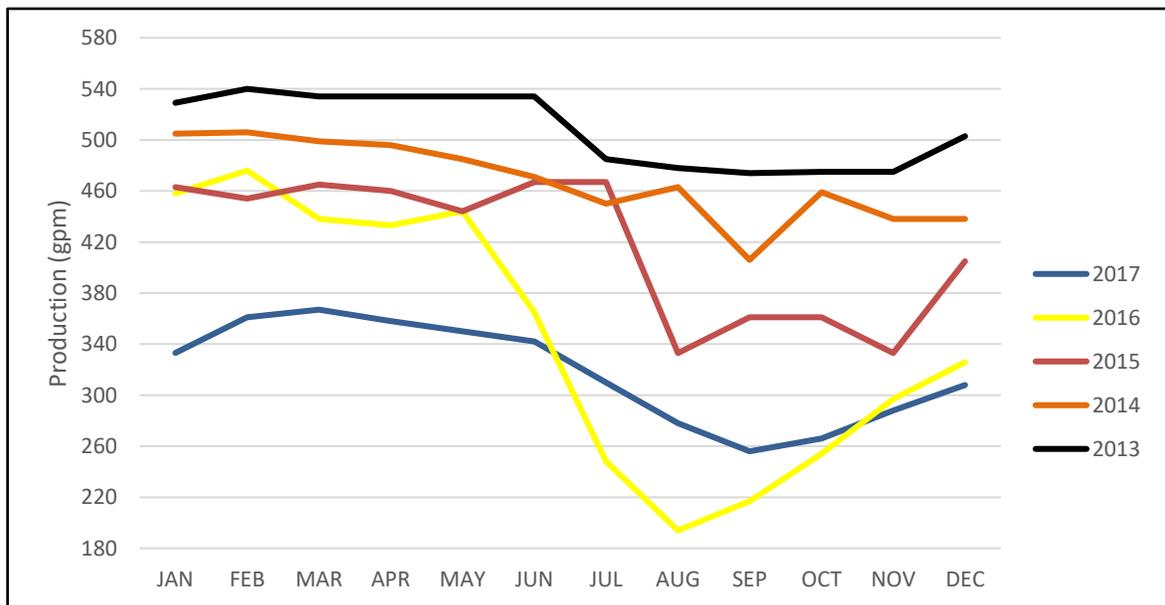
Figure 8 : Production from Well 8 from 2013 – 2017

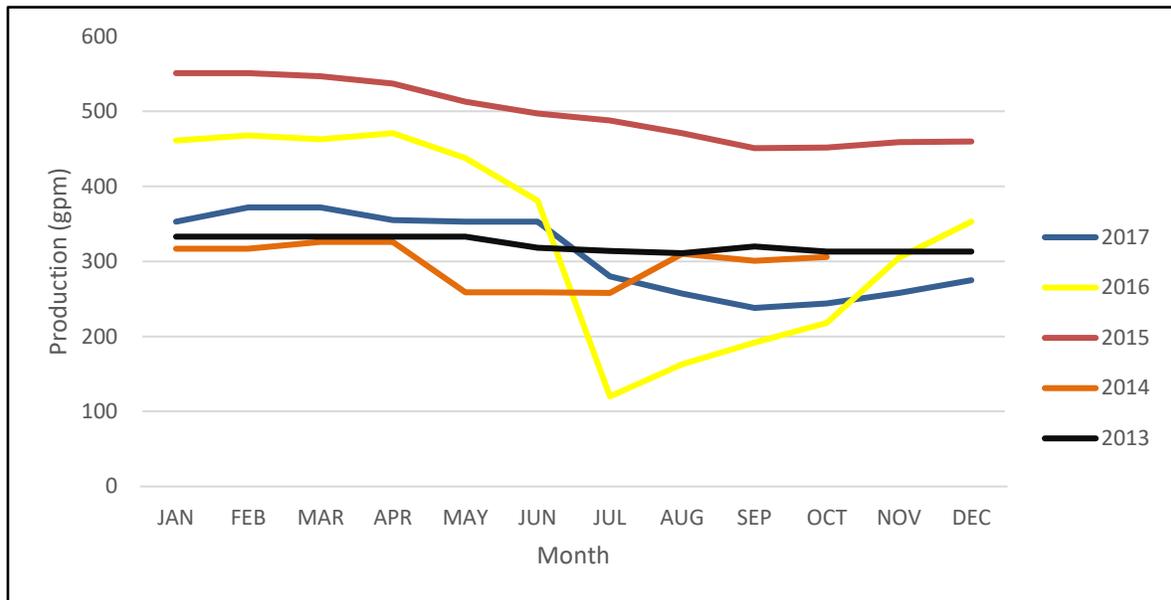
Figure 9 : Production from Well 5, 2013 - 2017

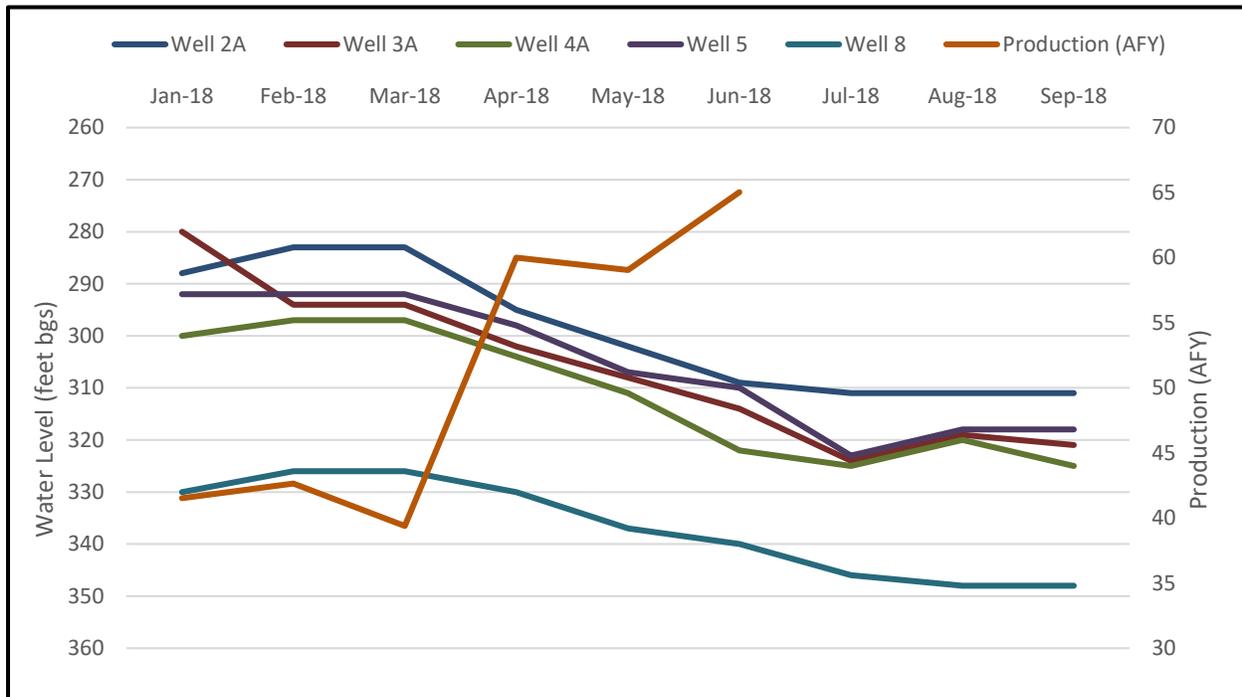
Figure 10: Static water levels for all wells and total system production in 2018

Through operational experience, the operators have determined that Wells 5 and 8 can be operated together continuously along with Well 2A. Production from Well 3A generally increases during the winter but declines during the summer months, making it unavailable for meeting high summer demand. A similar decline in production has also been observed for well 4A when operated in conjunction with the other wells. As of September 2018, the tunnel and wells 2A, 5 and 8 were producing a total flow of 400 gpm. Combined with the expected production of 250 gpm from Well 11, the total combined pumping capacity of SCWC in September, 2018 was 650 gpm.

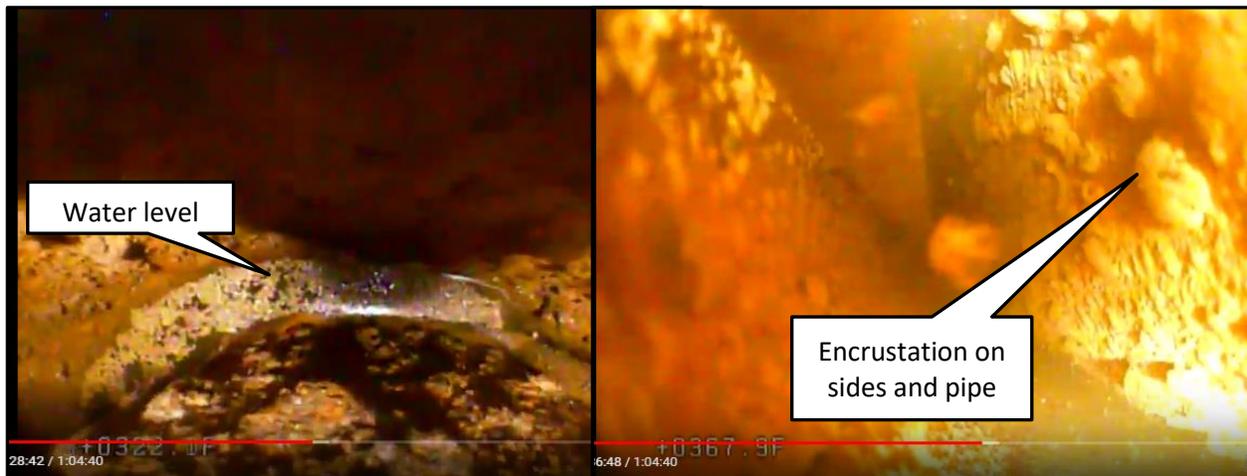
Figure 11: Video survey for Well 4A

Figure 11 shows stills of interior of Well 4A taken with the video camera.

The videos revealed that the milled slots in Well 4A are clogged with a white precipitate above the static water level. Some degree of exfoliation and metal peeling was also observed on the casing and pump column. Below the static water level, a significant degree of iron oxide scaling was observed with formation of tubercles. This indicates the presence of iron oxide bacteria. The milled slots also appeared to be clogged due to iron oxide scale. Well 3A was found to be in better condition. A moderate amount of iron scale was present on screen above the static water level, but increased with depth below the water level. The pump casing was found to be in better condition with no exfoliation. Some of the deposits in both wells were easily dislodged by the camera as it passed through the narrow space, suggesting that some of these deposits were formed recently. The clogged screens are likely contributing to the slow recharging of the well column and the diminished supply.

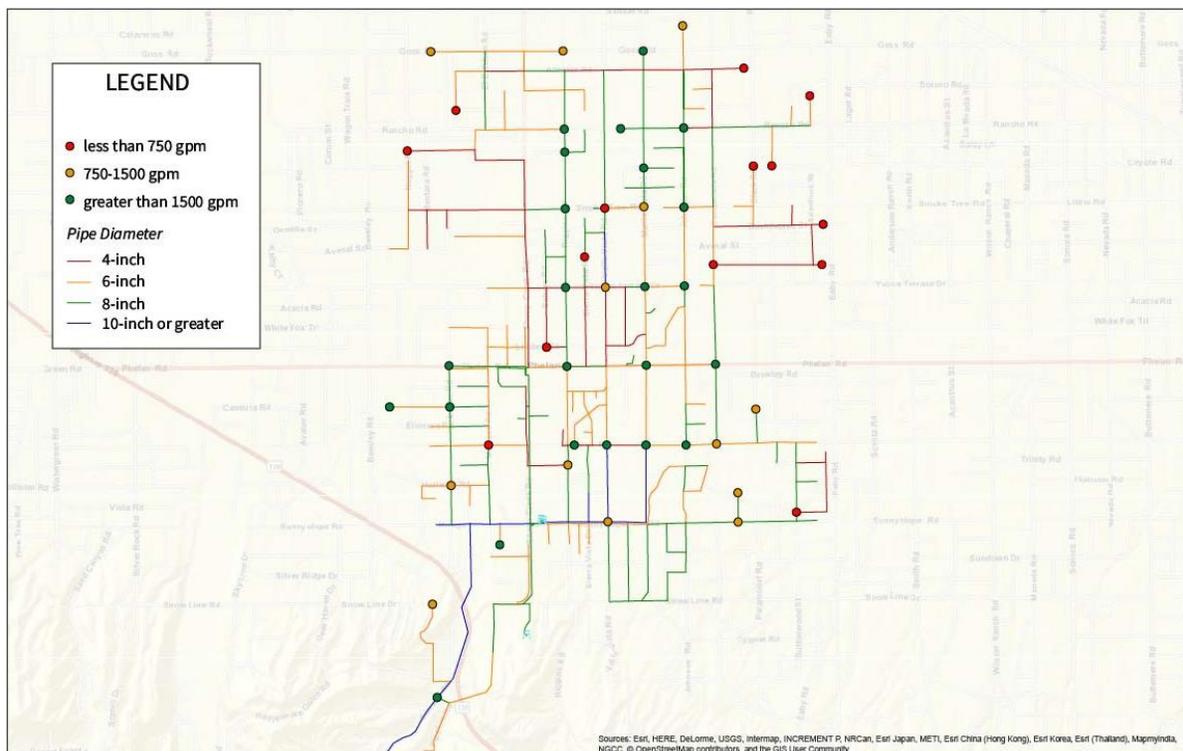
Figure 12: Fire flow inadequacies in distribution system

Approximately 60% of the locations modeled were unable to meet the fire flow requirement. Figure 12 shows the distribution system color coded by pipe diameter and flows modeled at fire hydrants. As can be seen in the figure, pipelines in some areas of distribution system are undersized and unable to handle a sustained flow of 1,500 gpm. Approximately 12 miles of pipelines within the system are 4-inch in diameter, which represents 17% of the total length of service lines. It was determined that minimum pipe size should be of 8-inch if the fire flow requirement is to be met.

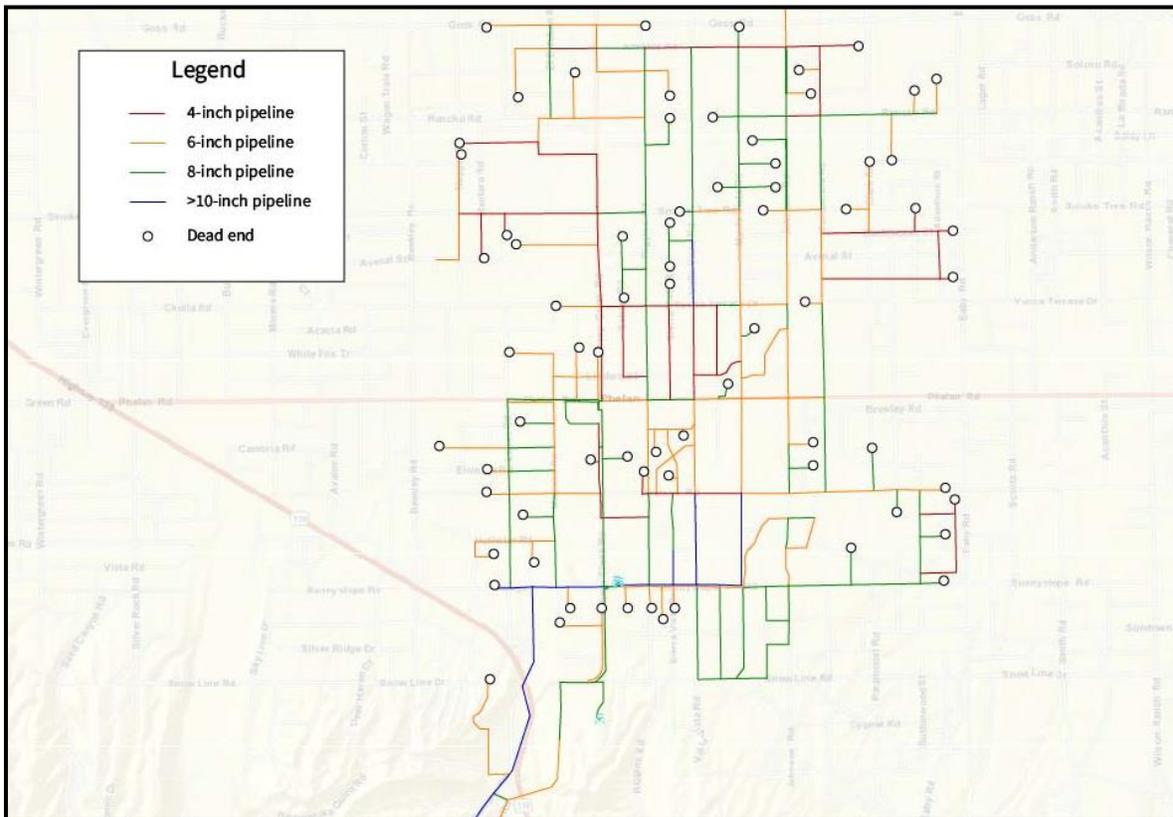
Figure 13: Dead ends throughout distribution system

There are over 110 dead ends throughout the distribution system, as shown in Figure 13. Some of these have no fire hydrant or blow off for flushing. Dead ends allow water to stagnate, which can lead to bacterial growth and poor tasting water. Fire hydrants should be provided at these dead ends to enable periodic flushing.

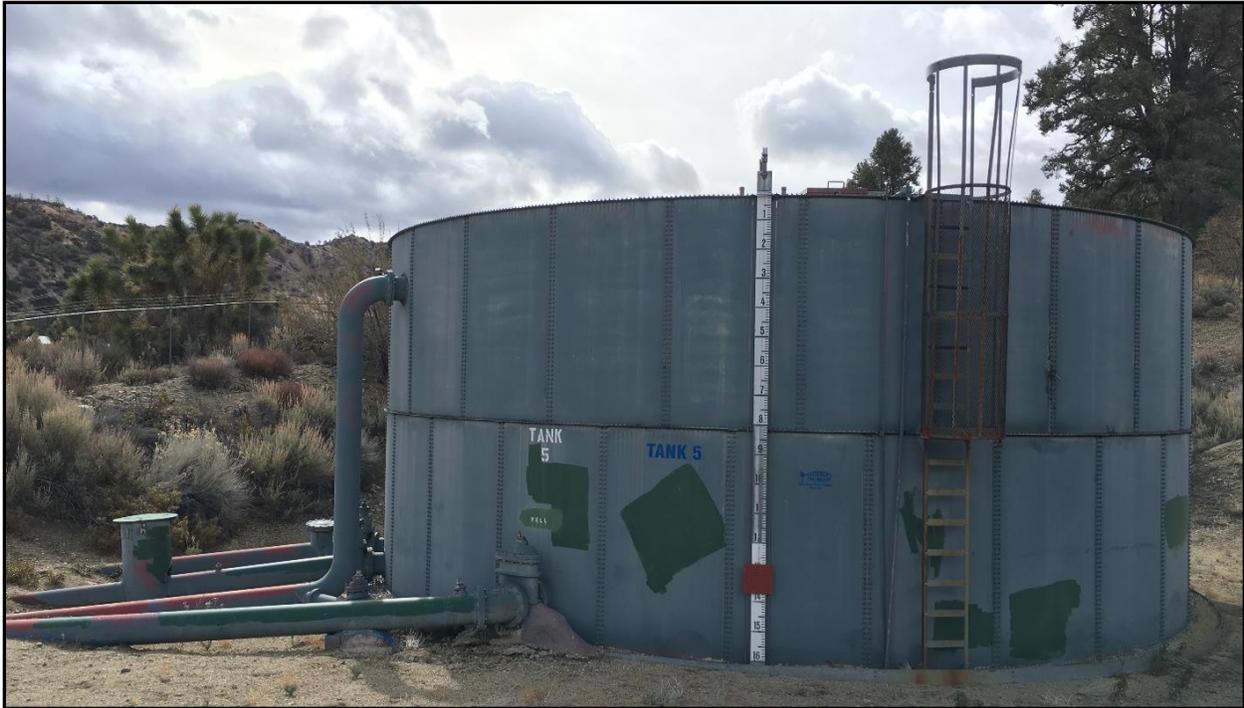
Figure 15: Storage Tank 5

coatings, corrosion control and other upgrades necessary to comply with existing OSHA regulations and AWWA standards. The cost of upgrades is discussed in Section C.2.4. Observed deficiencies are summarized in Table 6. Figure 15 shows UV damaged exterior coatings for one of the storage tanks, Tank 5.

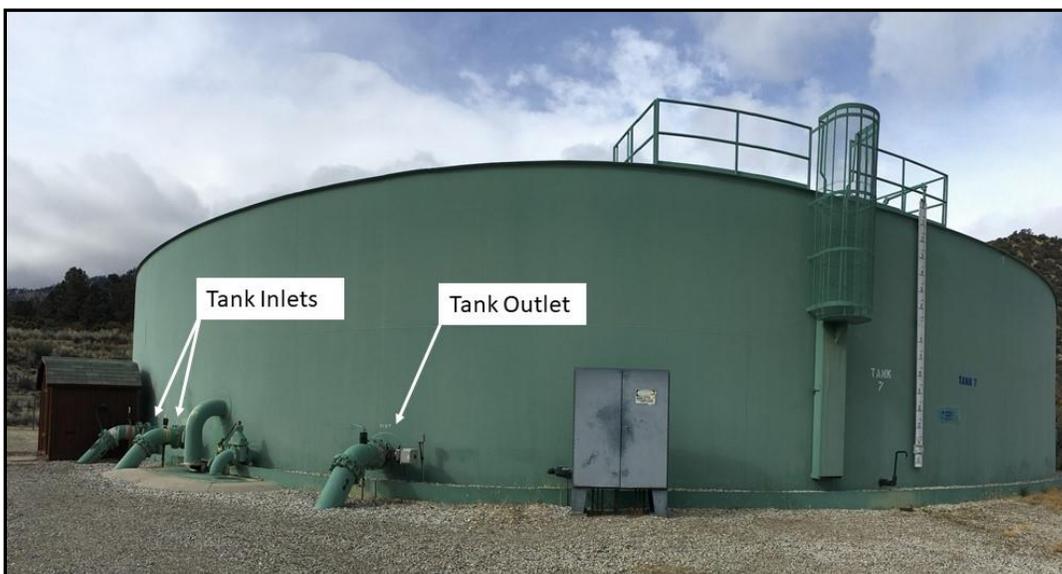
Figure 16: Tank 7 - inlets and outlet

For all of the tanks, the inlet and outlet pipes are both located at the bottom of the tanks on the same side, as shown in Figure 16 for Tank 7. This configuration does not promote internal water circulation, which can lead to stagnation and depletion of the chlorine residual resulting in microbial growth, as well as taste and odor issues. Although, currently there are no known issues within the system due to lack of circulation, it is recommended that mixers be installed inside all of the tanks. In the interim, the system should monitor chlorine residual in the tank effluent daily to continue to avoid any bacteriological growth within the tanks.

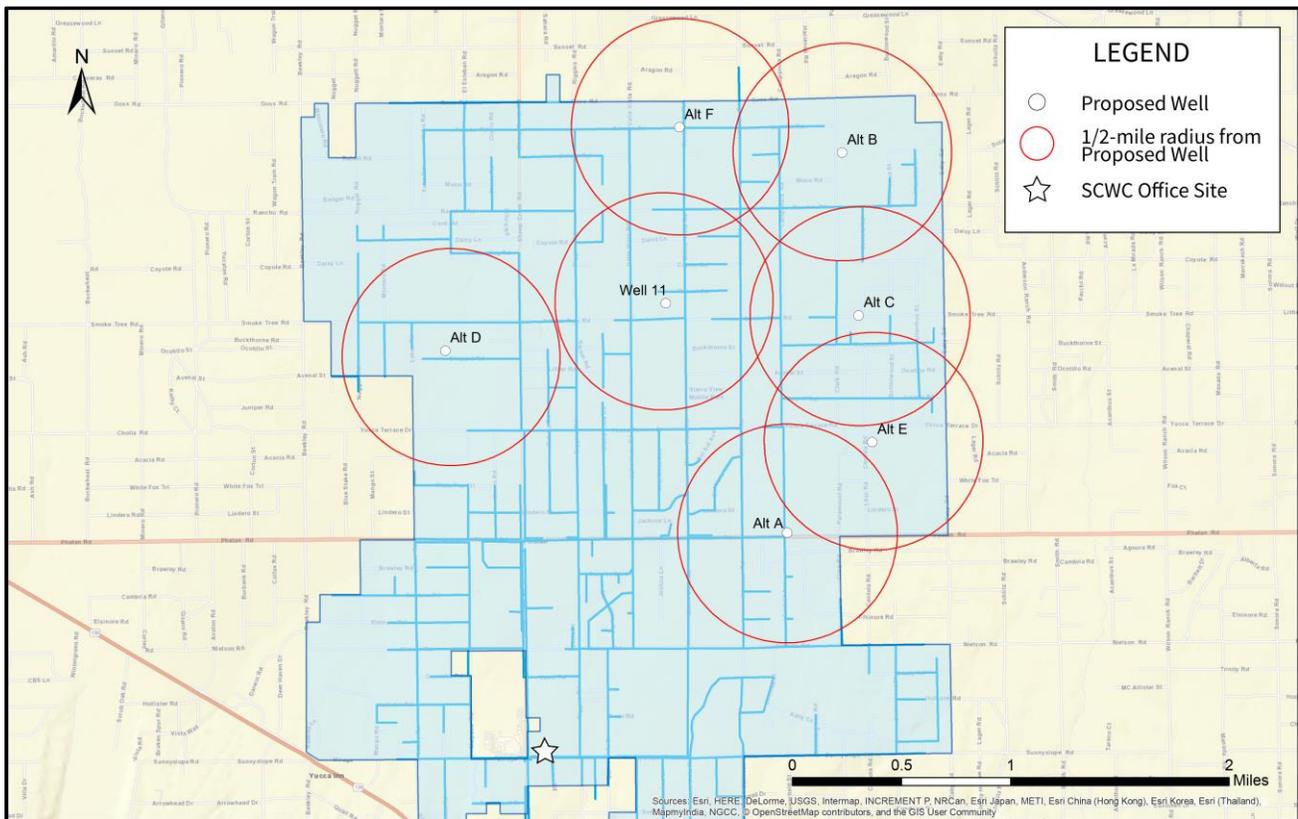
Figure 17: Locations of proposed alternatives for drilling additional wells

The six alternative locations are shown in Figure 17. All of these are expected to produce flows in the range of 200 – 400 gpm, as indicated by yield from other similar wells in the area. Locations A and D are in close proximity to existing SCWC infrastructure and therefore can be considered more desirable than others. The number of new wells needed would depend on flow obtained from each well. CRWA recommends that three locations be selected for pilot test borings and drilled for testing. Depending on the flow and water quality obtained from these wells, the necessity of additional test wells can be determined.

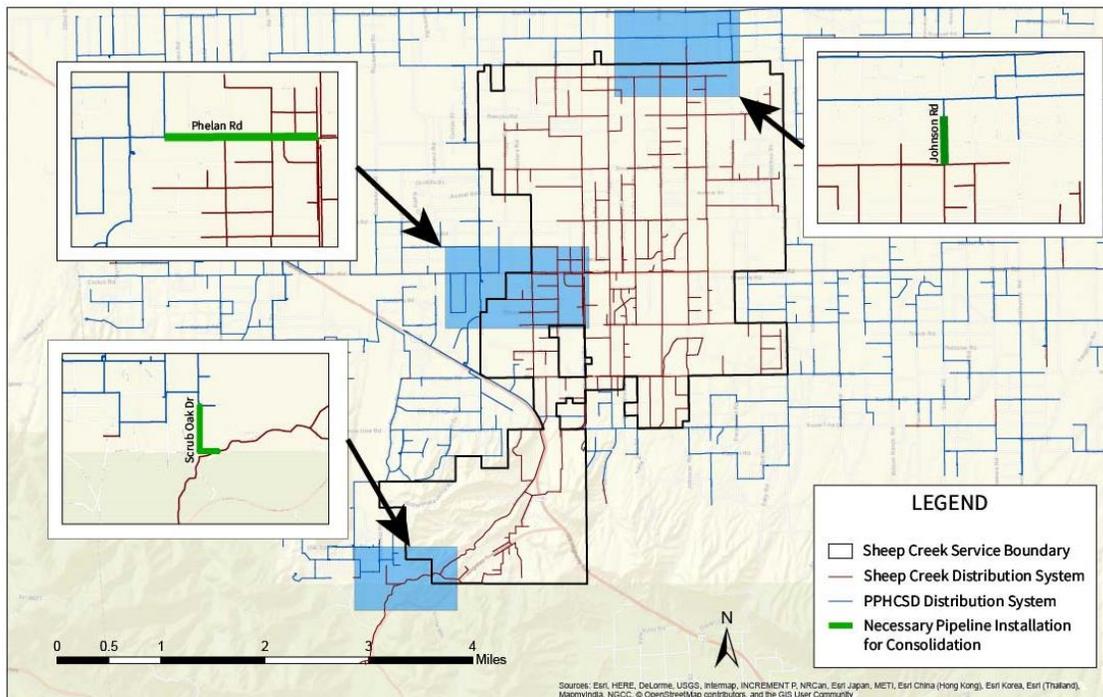
Figure 20: Connection points for consolidation

Environmental impacts of laying out these pipelines to connect the two systems are considered minimal because the new appurtenances will likely be installed on paved roads and previously disturbed areas within public right of way.

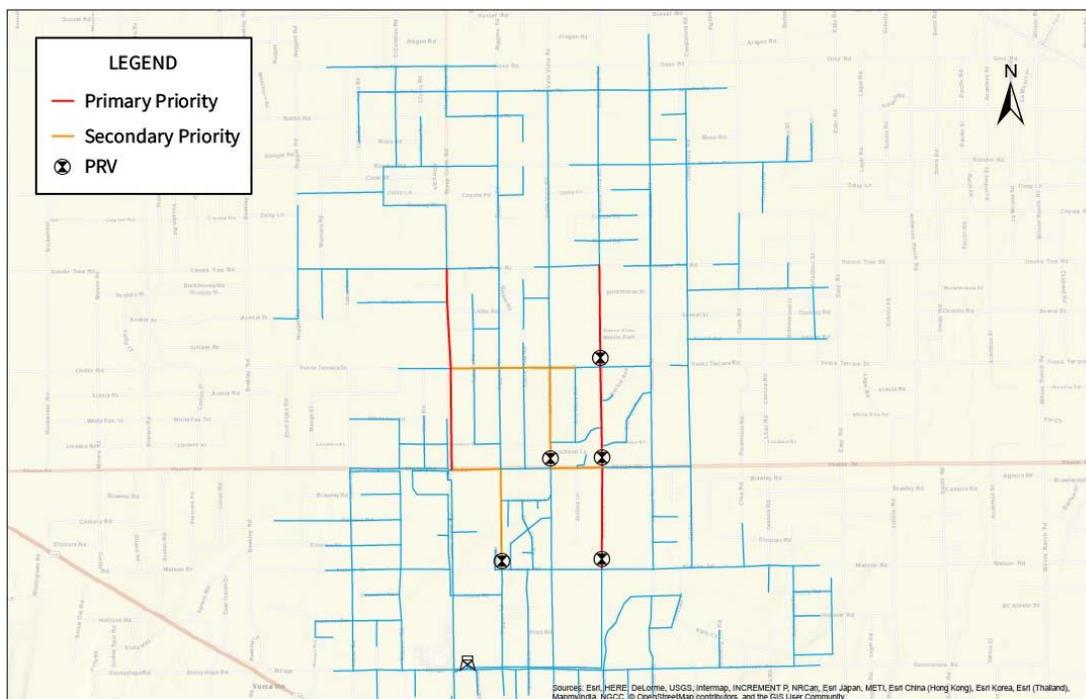
Figure 21: Replacement of distribution system pipelines

Item	Unit	Qty	Unit Cost	Total Cost
8-inch C900	Linear foot	25,500	\$100	\$2,550,000
PRVs	Lump Sum	5	\$50,000	\$250,000
Total Cost for all pipeline replacements				\$2,800,000

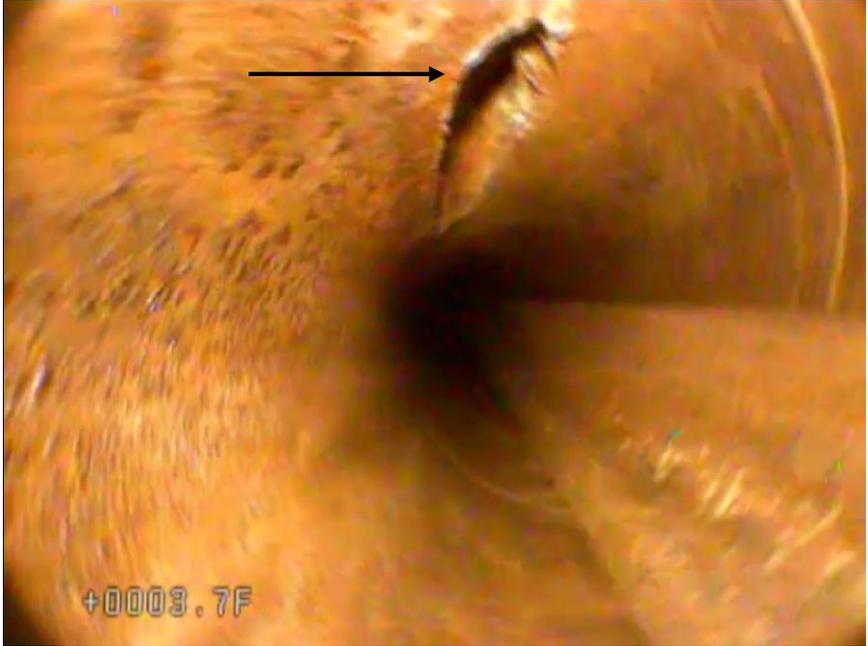
<p data-bbox="737 1182 1923 1279">Large gash present in the well casing at the top of the casing. Because of the size of the gash, and its location above the water level, it is unlikely to have been caused by corrosion. Most likely, the gash was created during the installation of the pump into the well when the well was drilled.</p>

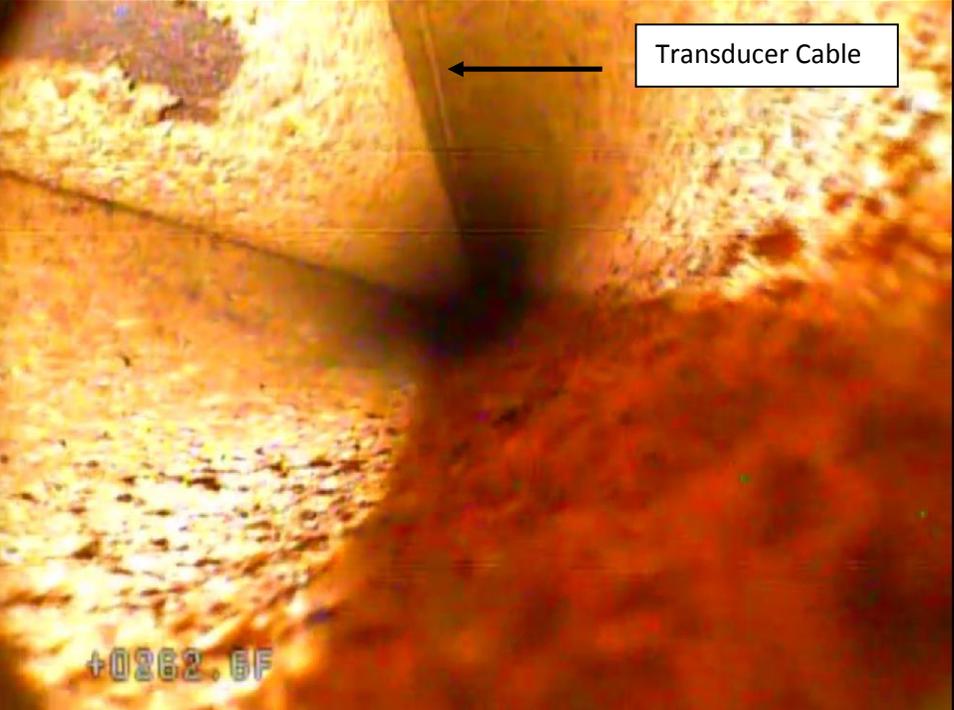
<p data-bbox="730 1057 1936 1122">Heavy rust on casing and pump column. Flaking of rust material from the pump column can be seen. Transducer cable visible.</p>

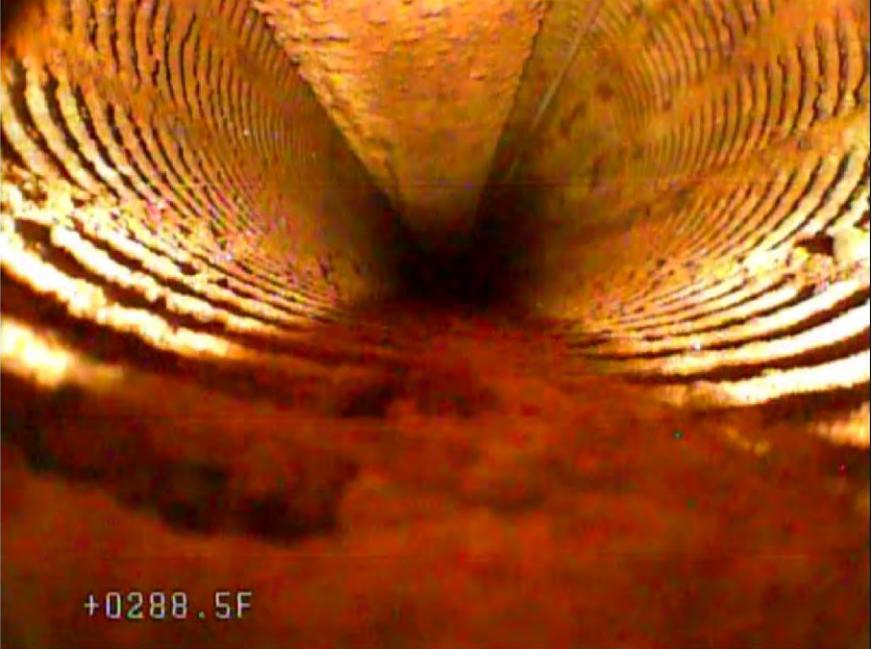
<p data-bbox="747 1052 1913 1117">Top of screen above static water level. 31.5 Ft. of louvered well screen is exposed above the static water level.</p>

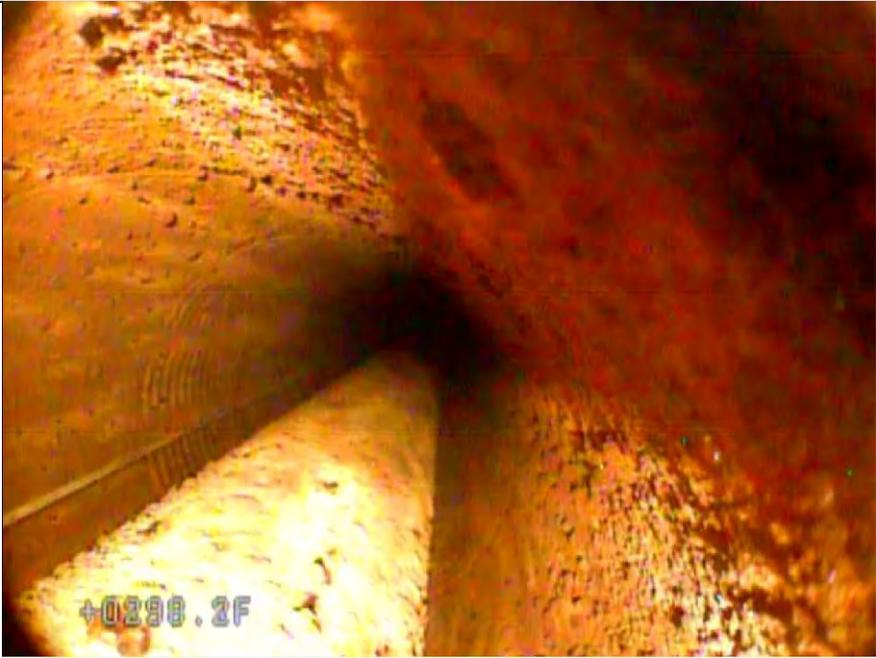
<p data-bbox="785 1130 1871 1192">Welded casing joint in well screen indicates that well screen was installed in 10 Ft. sections. Transducer cable still visible.</p>

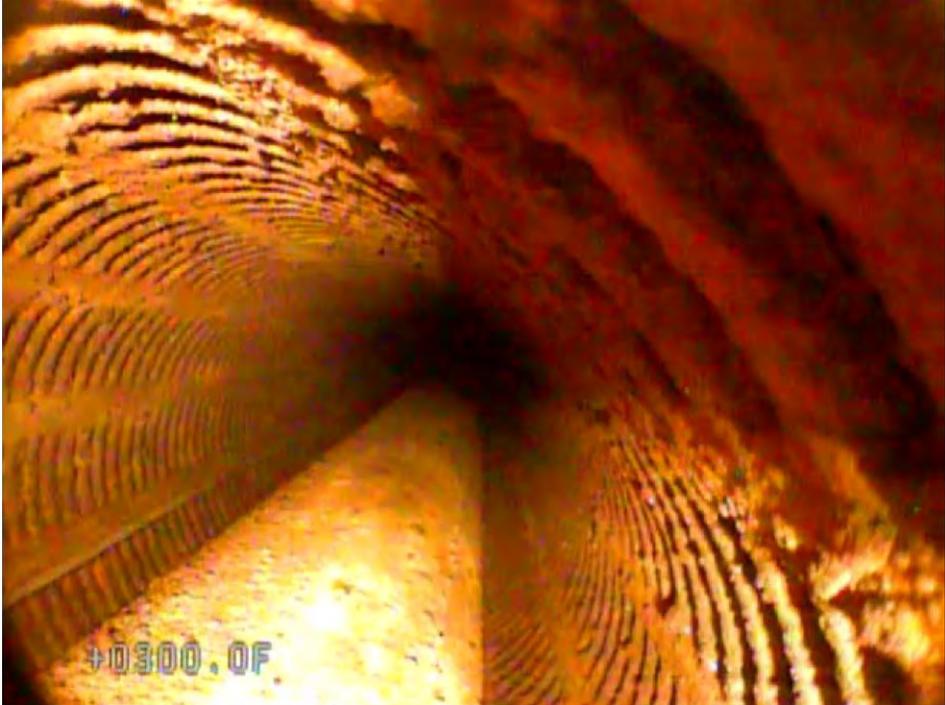
Pumping Rate (GPM)	Depth (Ft. BGS)	Video Time (hh:mm:ss)	Image & Description
Static conditions	300 Ft. BGS	00:17:29

<p data-bbox="905 1105 1751 1138">Screen continues above static water level. Transducer cable still visible.</p>

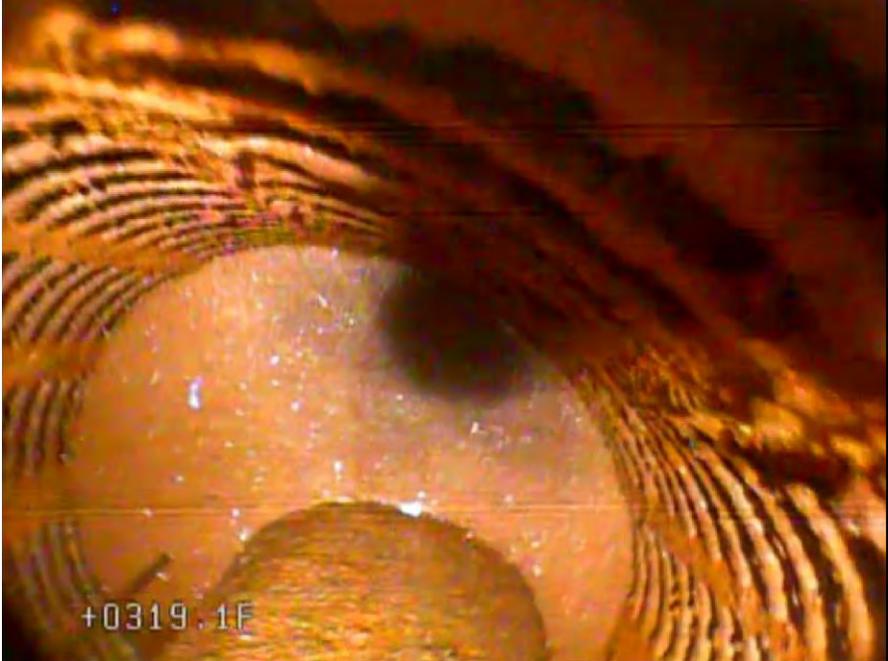
<p data-bbox="737 1101 1919 1162">Static water level. Photo still from 319.1 Ft.BGS. Actual static water level was measured at 320.1 Ft. BGS.</p>

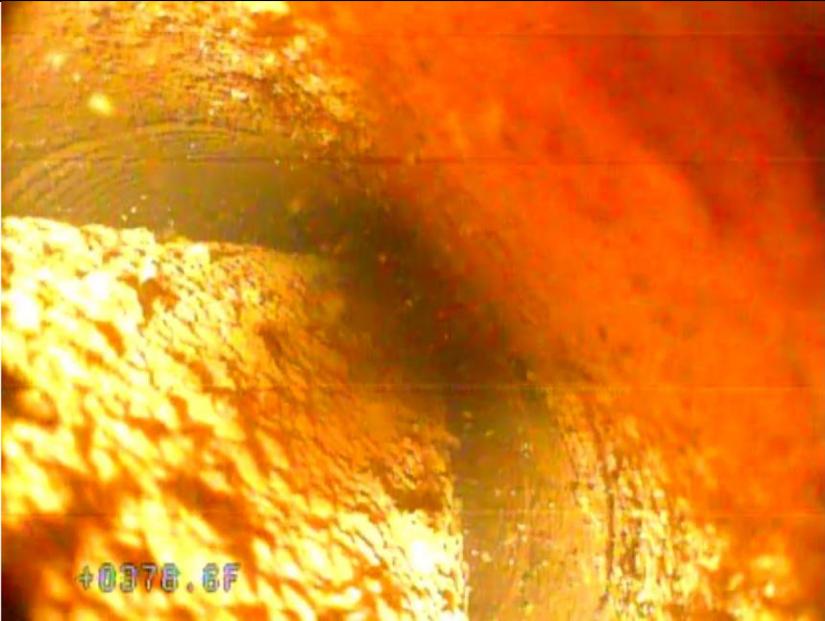
<p data-bbox="732 1052 1923 1117">Second welded casing joint in well screen. Transducer not visible at this depth. Heavy build up along well screen, but louver openings are still easily visible.</p>

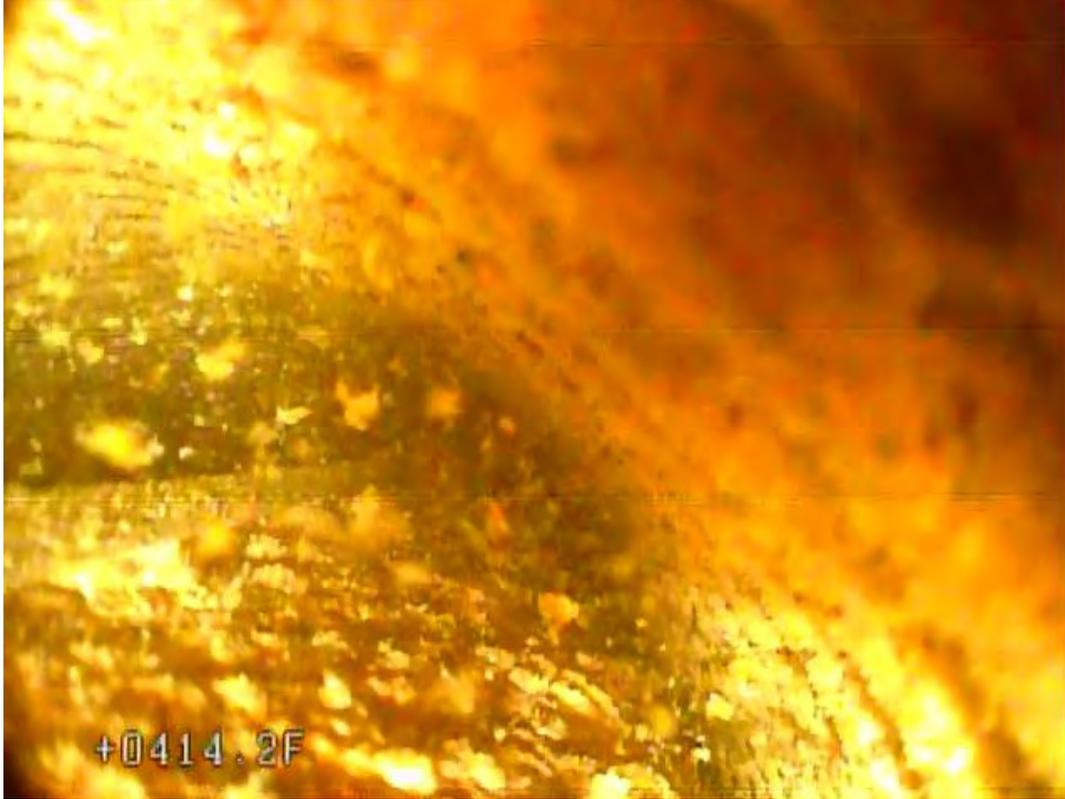
<p data-bbox="1031 1182 1625 1214">Material build up on screen increases with depth.</p>

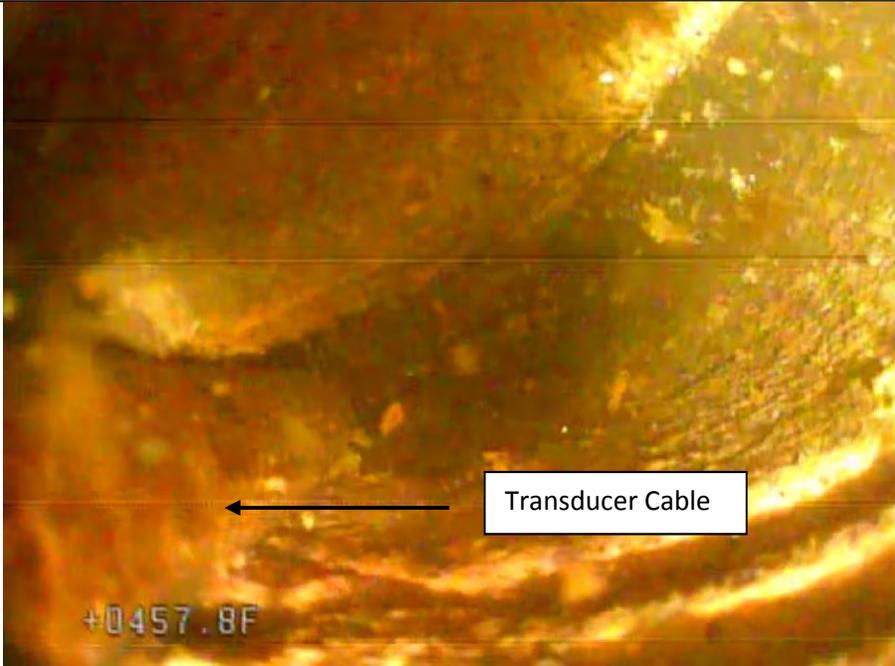
<p data-bbox="951 946 1136 982">+0457.8F</p> <p data-bbox="1365 816 1623 878">Transducer Cable</p> <p data-bbox="951 1049 1707 1081">Top of pump bowls. Housing pipe where transducer cable ends.</p>

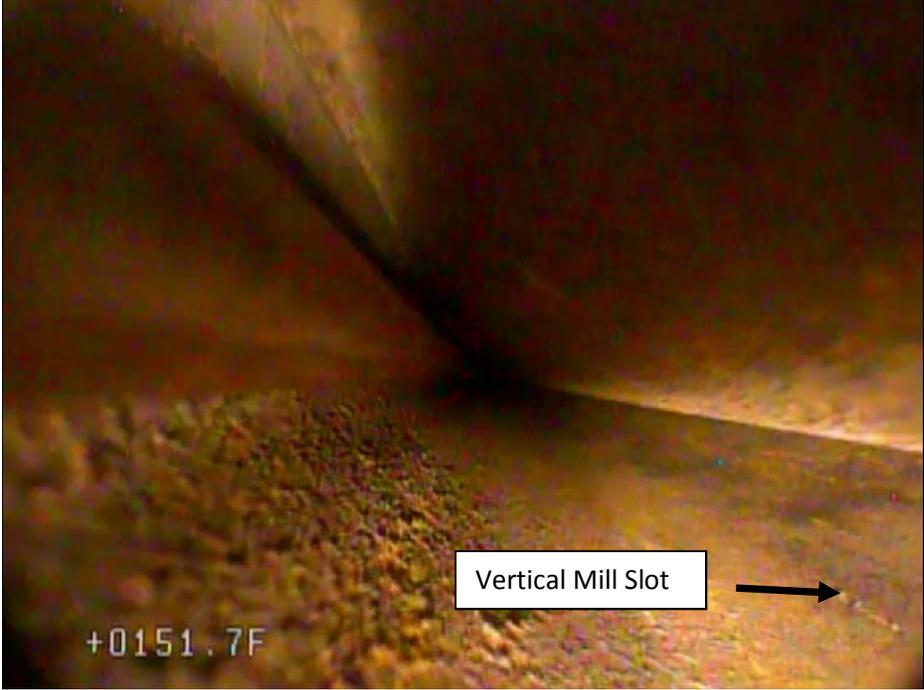
<p data-bbox="743 1182 1919 1252">First slots observed in the screen, screen may start sooner but could not be seen (arrow where slot was visible). Instrument tube can be seen on left side of image.</p>

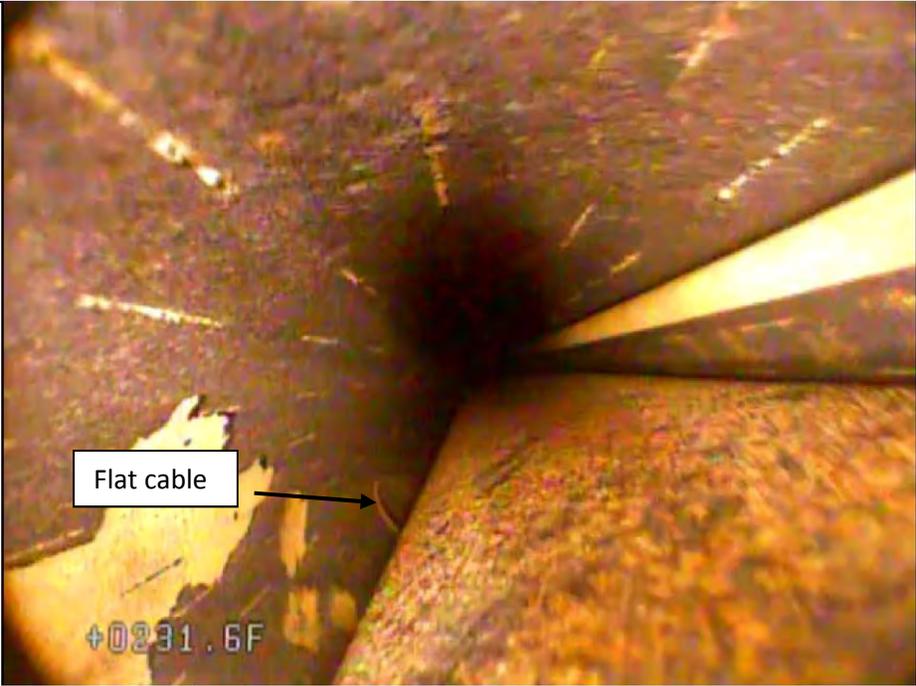
<p data-bbox="730 1157 1927 1255">Possibly starting point where scaling from hard water begins. Similar patches of scaling continue until 243.1 Ft. BGS where scaling becomes denser. A flat cable can be seen just below scaling. End of cable was not seen.</p>
