**SAFE DRINKING WATER STATE REVOLVING FUND
APPLICANT ENGINEERING REPORT**

Water System Name: Sheep Creek Water Company

Project Number: 5207-A

Engineering Report Sheep Creek Water Company

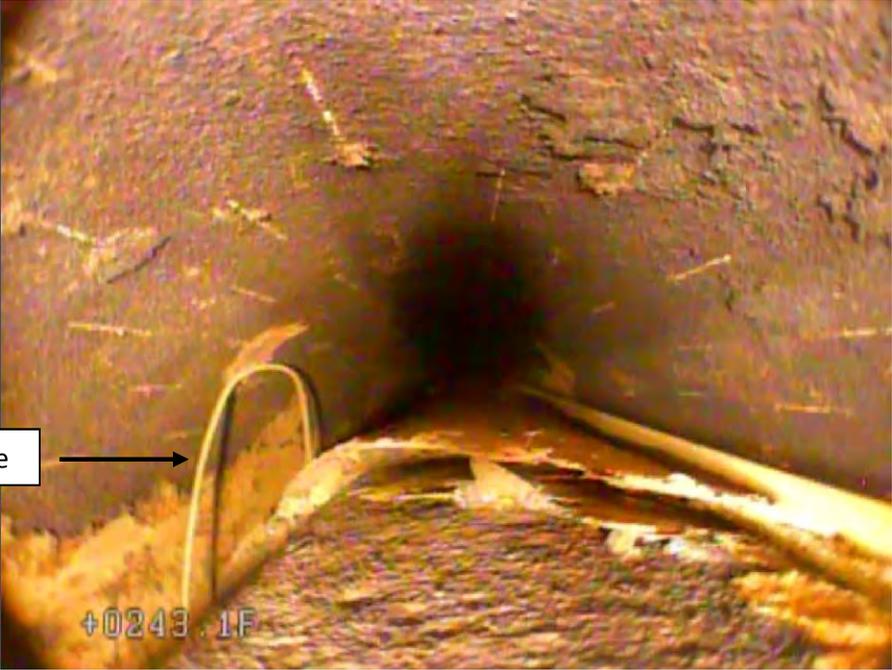
<p data-bbox="758 857 921 914">Flat cable →</p> <p data-bbox="873 1143 1787 1170">Hard water deposits continue in patches along casing. Flat cable still present.</p> <p data-bbox="961 1036 1138 1073">+0243.1F</p>

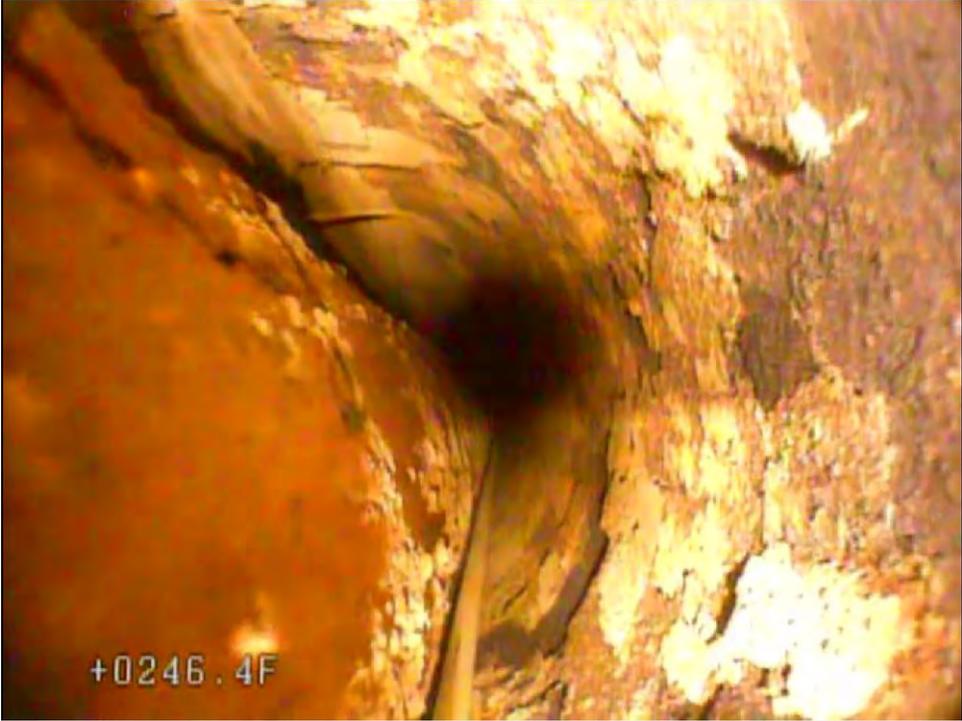
<p data-bbox="1066 1157 1587 1187">Hard water scaling starts to become dense.</p>

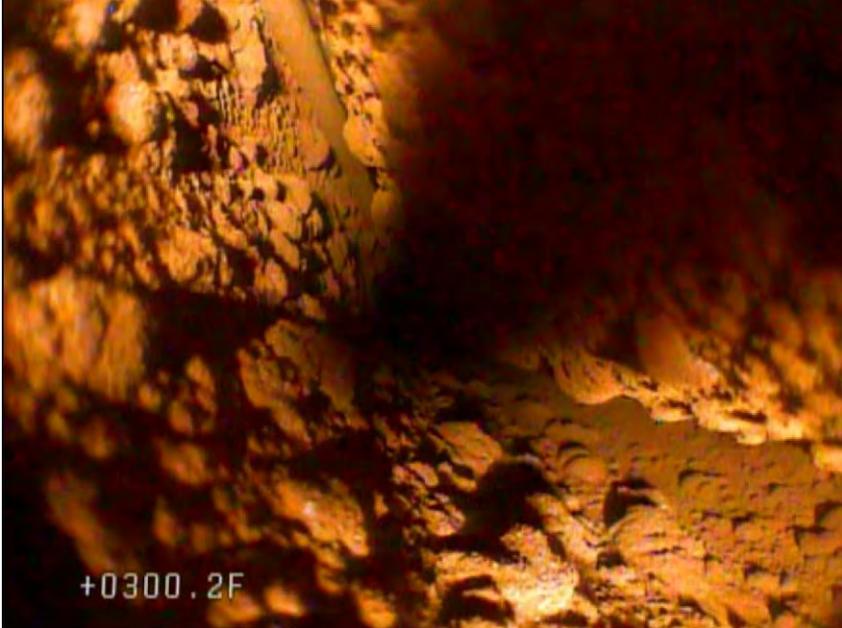
<p data-bbox="1089 1068 1564 1097">Hard water scaling increases in density.</p>

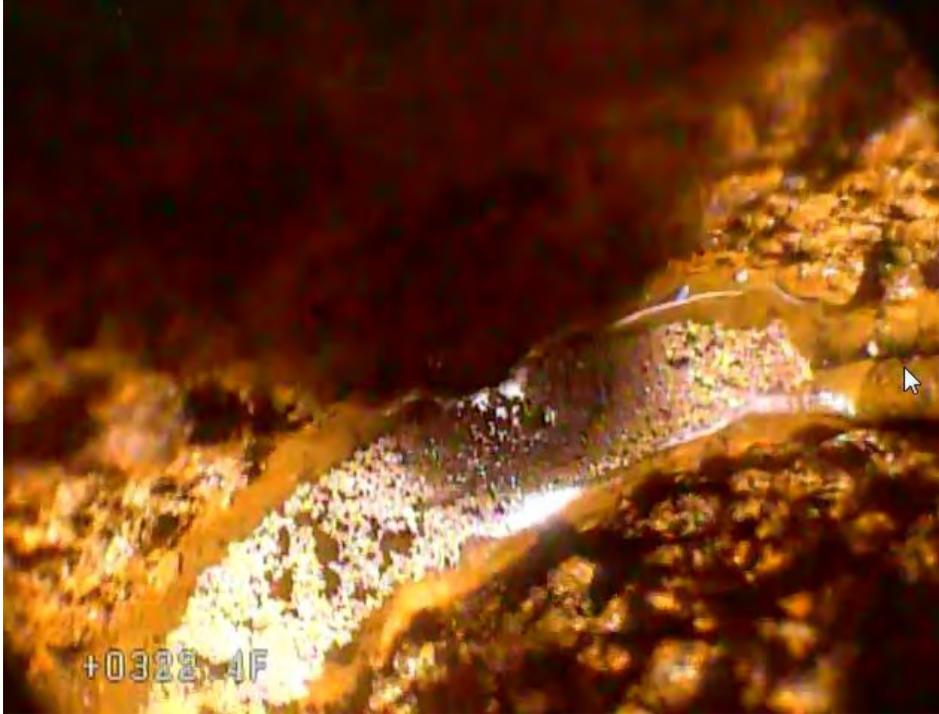
Pumping Rate (GPM)	Depth (Ft. BGS)	Video Time (hh:mm:ss)	Image & Description
Static conditions	322.4 Ft. BGS	00:28:47

<p data-bbox="831 1149 1829 1179">Static water level. Photo still from 322.4 Ft. BGS. Actual water level at 322.7 Ft. BGS.</p>

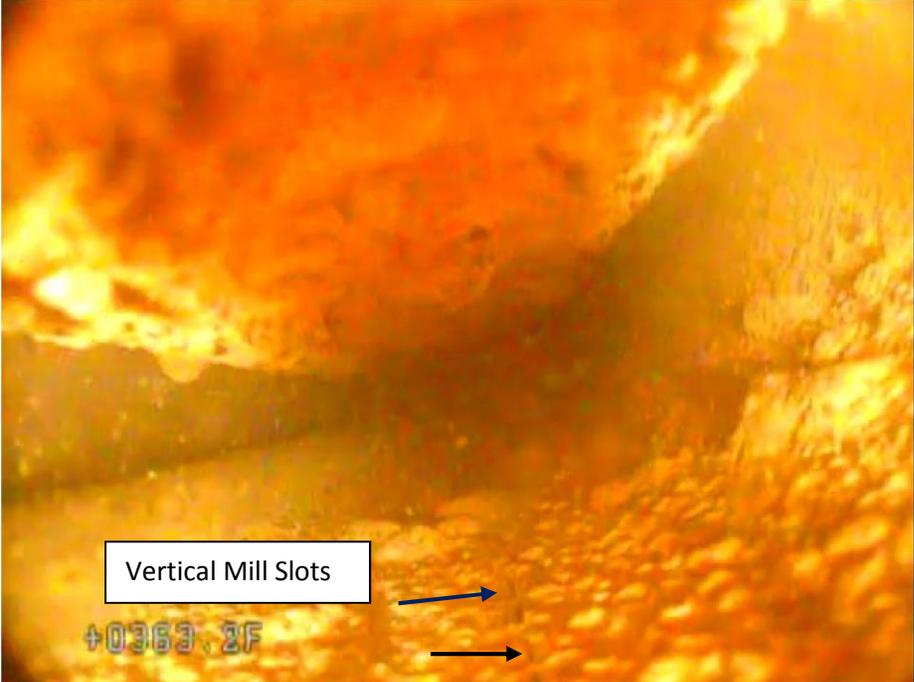
<p data-bbox="968 938 1241 998">Vertical Mill Slots</p> <p data-bbox="953 1019 1136 1057">+0363.2F</p> <p data-bbox="968 1122 1688 1154">Slots in screen start to become visible again through scaling.</p>
