A down-hole static video survey was performed by BESSST, Inc. inside Sheep Creek Well 3A on July 24th, 2018. The video survey was performed using a miniaturized camera, measuring 0.75" OD and configured for color imaging. The focus of the investigation was to evaluate the condition of the well screen throughout the perforated section to determine the potential cause(s) of production losses; as well as to use the video data to formulate potential remedies for remediating the problem. The intent of the survey was to reach the bottom of the well, located at 500 Ft. BGS, this was not possible due to sediment fill that blocked the camera survey to reach the bottom of the well. As a result, the survey was completed to a depth of 494 Ft. BGS

A down-hole static video survey was performed by BESSST, Inc. inside Sheep Creek Well 4A on July 24th, 2018. The video survey was performed using a miniaturized camera, measuring 0.75" OD and configured for color imaging. The focus of the investigation was to evaluate the condition of the well screen throughout the perforated section to determine the potential cause(s) of production losses, as well as to use the video data to formulate potential reme

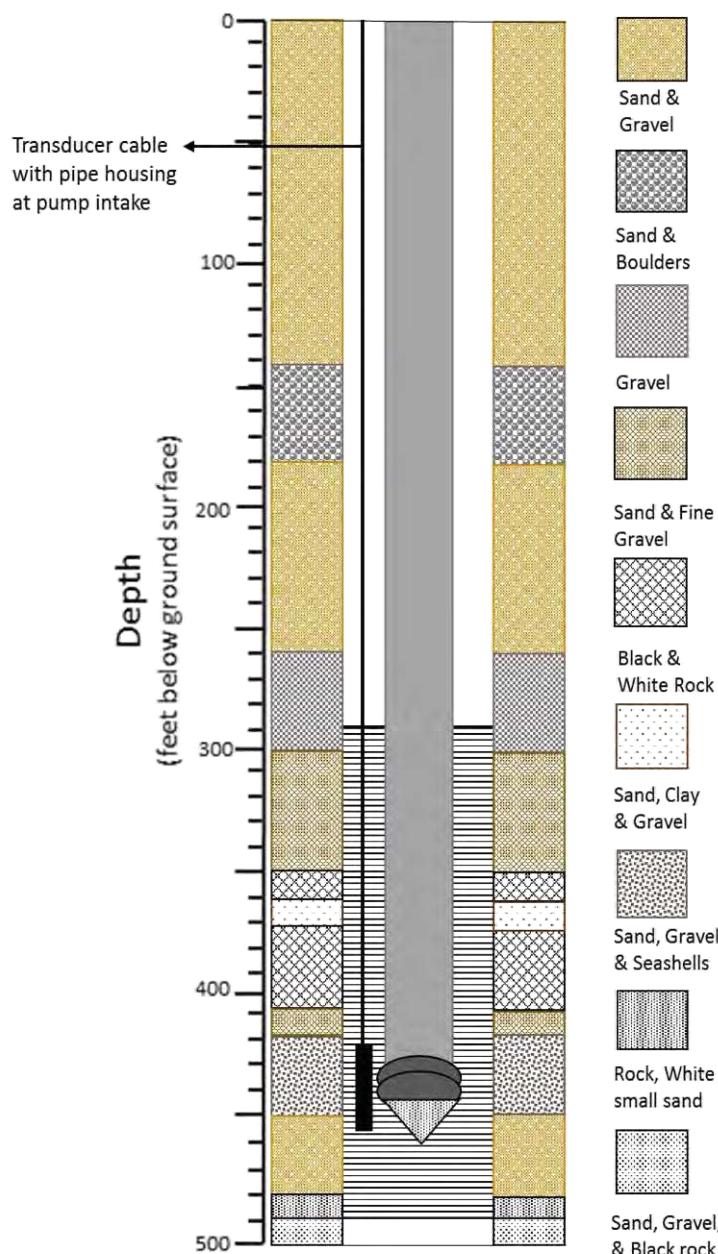
The video survey showed that the well screen consists of louvered screen. It was discerned that the louvered screen begins at a depth of 290 Ft. BGS and appears to extend continuously to 490 FT. BGS. First water inside the well was observed at a depth of 320 Ft. BGS. The distance from the top of well screen to first water measured 31.5 feet.

Well Information	Diameter Inches	GPM	Ft. BGS
Total Well Depth			500
Type of Pump: Vertical Turbine			
Pump Diameter	11		
Access Pipe Diameter			
Pump Column Diameter	8		
Pump Intake Depth			460
Static Water Level			320
Pumping Water Level*			Static conditions
Pumping Rate *		Static conditions	
Casing and Well Screen Intervals			
Gravel Pack			50-500
Blank			0-290
Perforated (louvered)	16"		290-490
Blank	16"		490-500

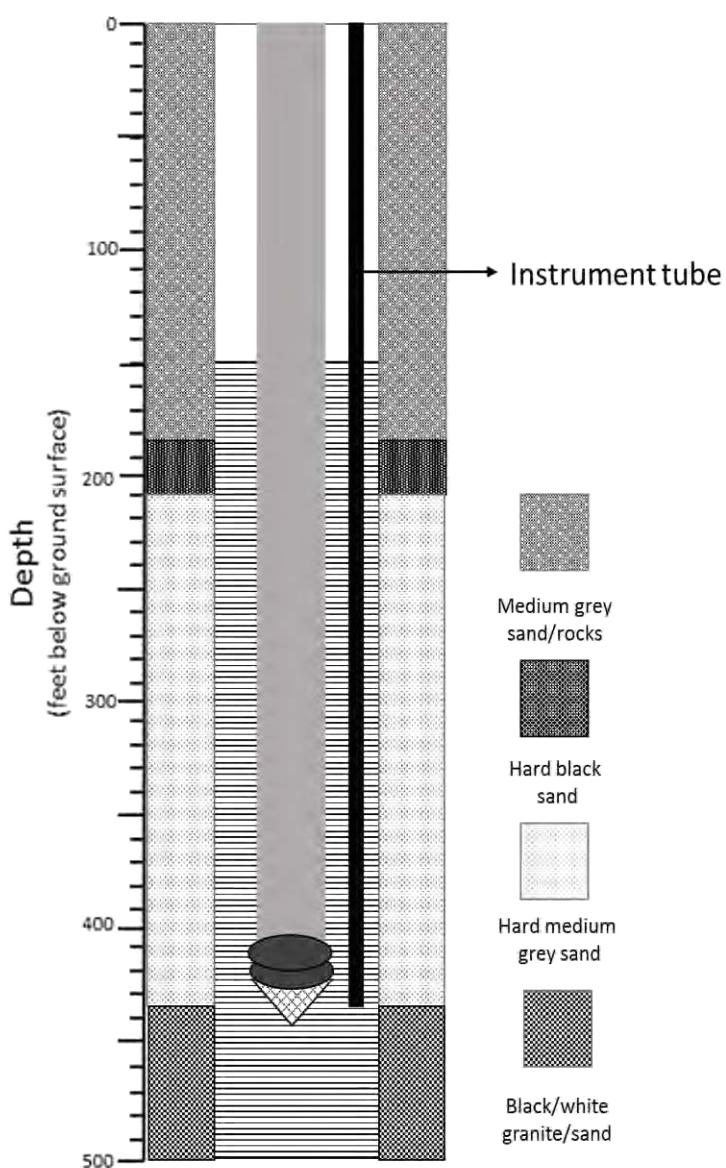
The video survey showed that the well screen consists of vertical mill slots. It was discerned that the mill slots begin at a depth of 150 Ft. BGS, and appear to extend continuously to the survey end depth of 438.8 Ft. BGS. Well records for Sheep Creek Well 4A, provided by CRWA, show that the mill slots extend to a depth of 500 Ft. BGS., which coincides with the bottom of the well. First water inside the well was observed at a depth of 322.7 Ft. BGS. The distance from the top of well screen to first water measured 171 feet.

Well Information	Diameter Inches	GPM	Ft. BGS
Total Well Depth			500
Type of Pump: vertical turbine			
Pump Diameter	12		
Access Pipe Diameter			
Pump Column Diameter	10		
Pump Intake Depth			440
Static Water Level			323
Pumping Water Level*			Static conditions
Pumping Rate *		Static conditions	
Casing and Well Screen Intervals			
Gravel Pack			69-503
Blank	16"		0-150
Perforated (Mill-Slots)	16"		150-500
