Asset Management Plan

Sheep Creek Water Company
4200 Sunnyslope Rd
Phelan, CA 92371

December 15, 2020

Infrastructure Engineering Corporation
1401 Commercial Way, Suite 100
Bakersfield, CA 93309

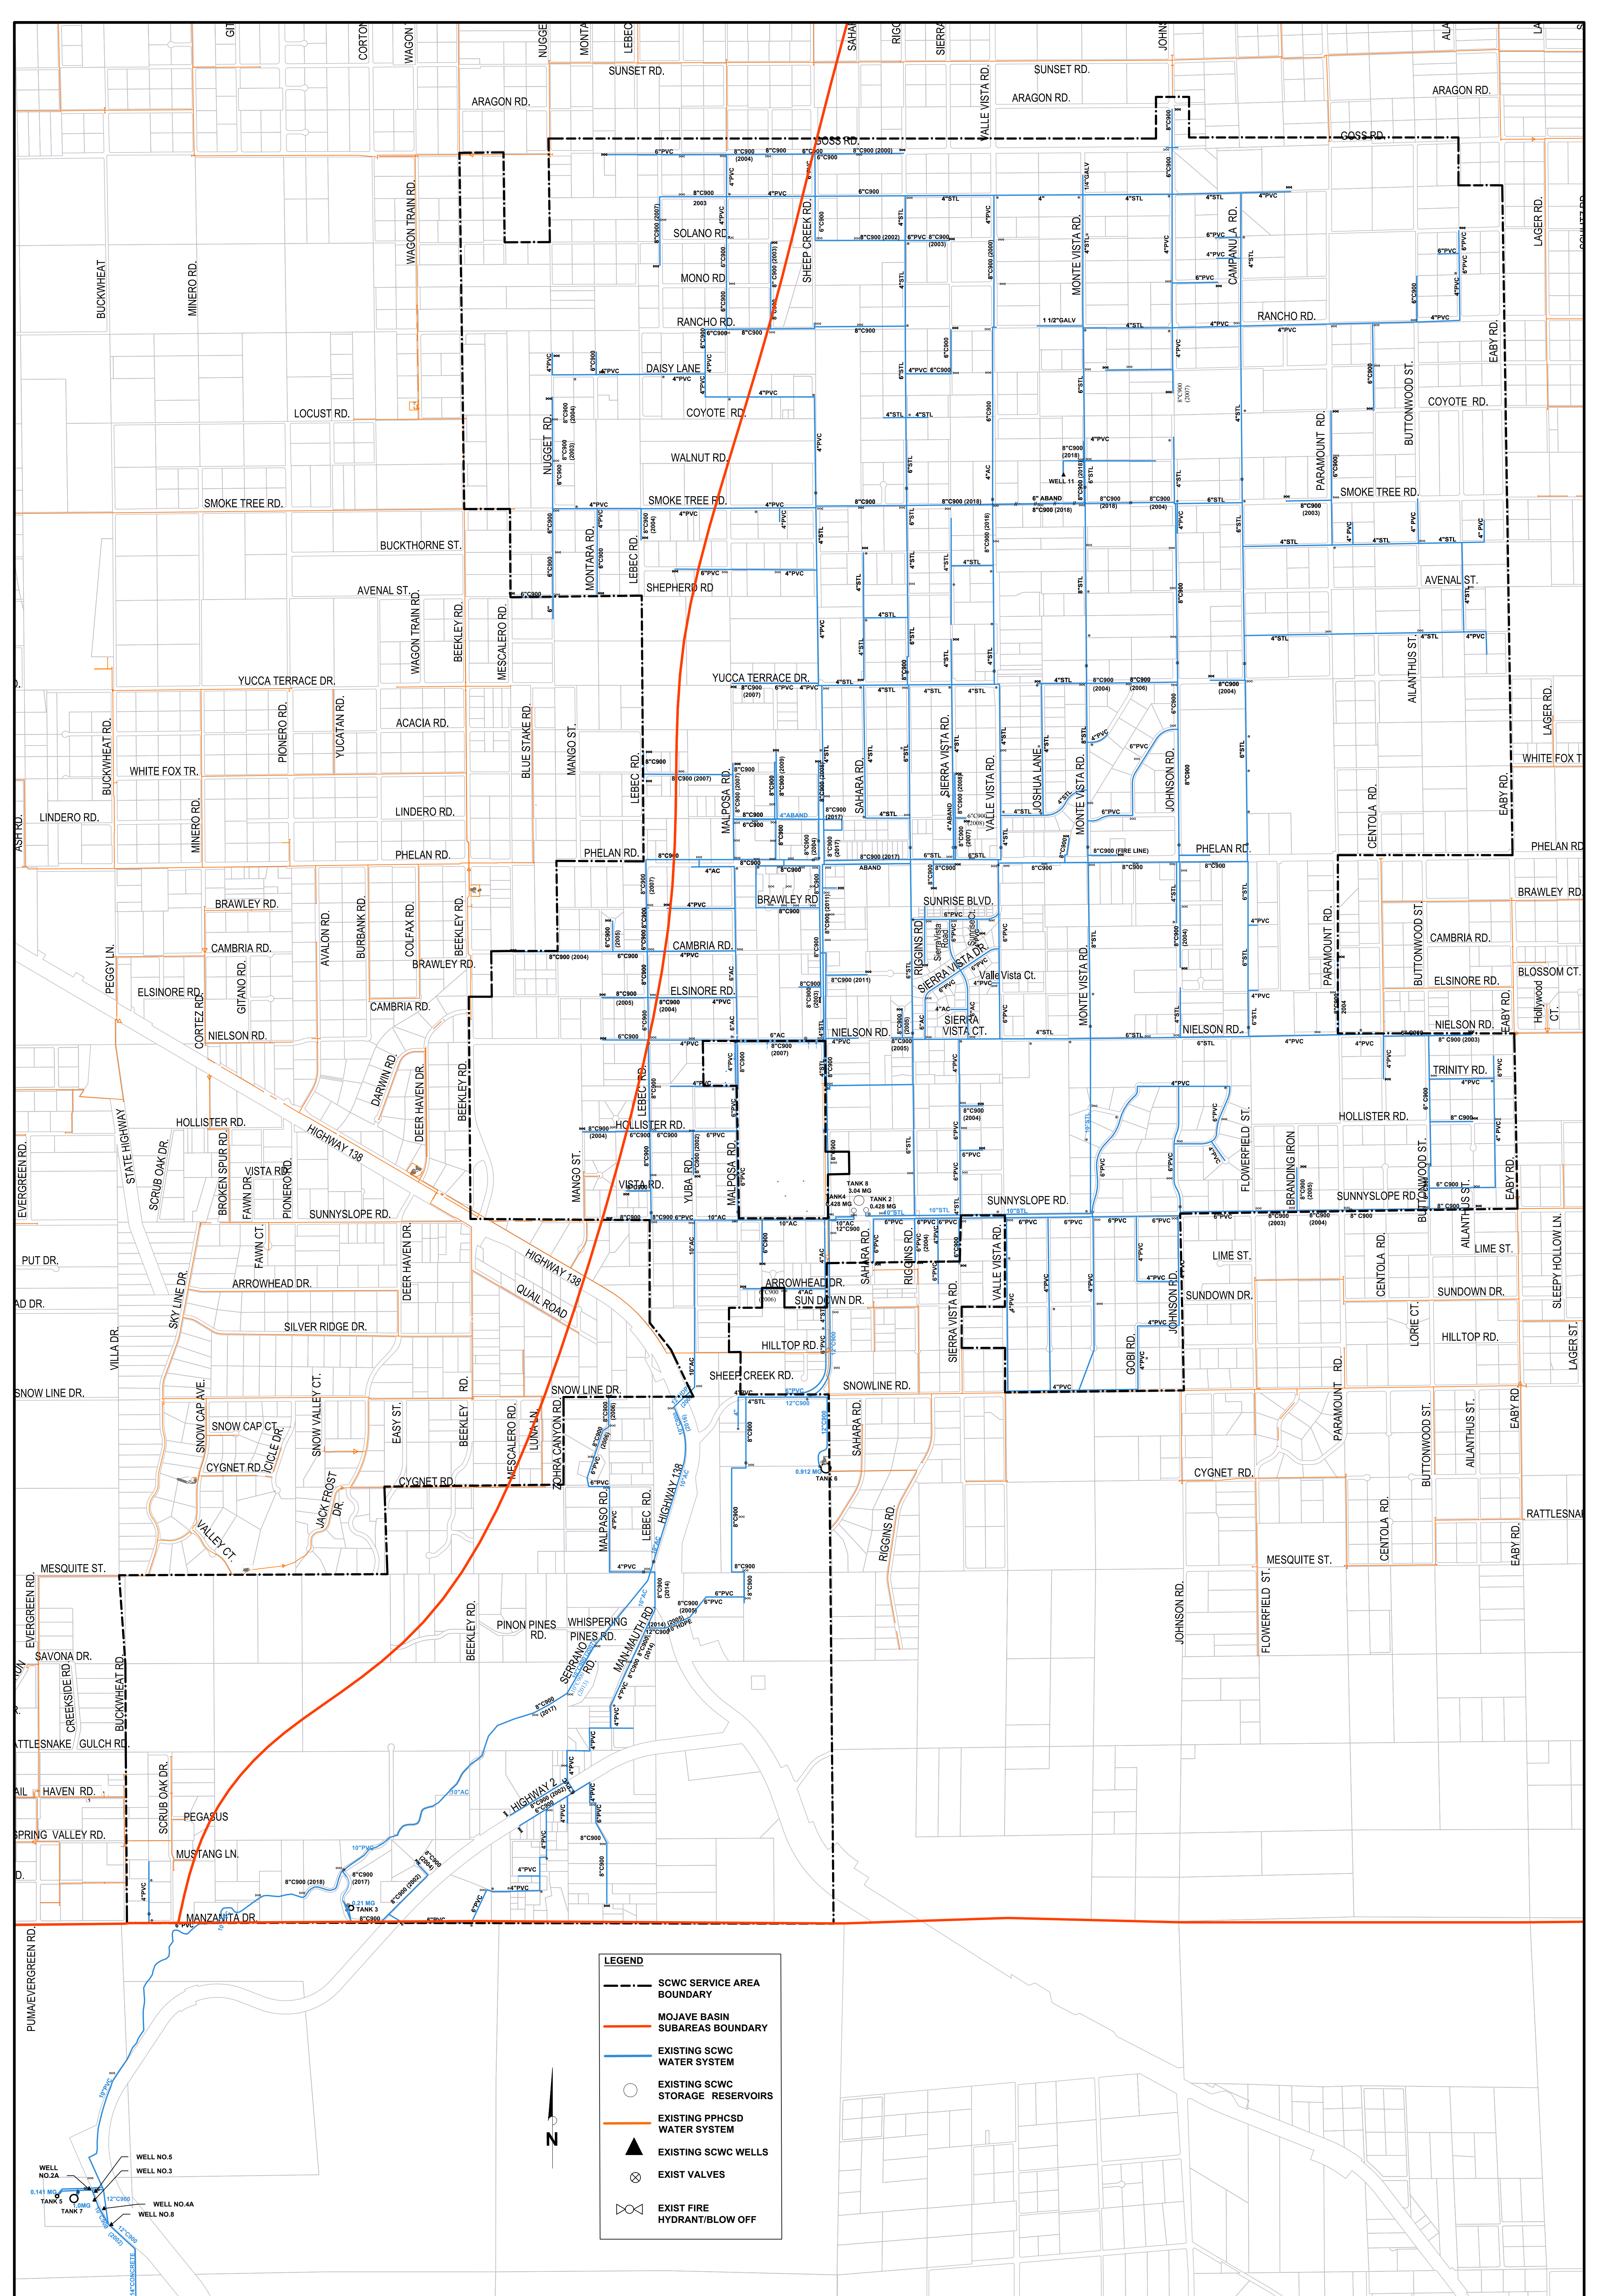
FIGURE 1

Figure 1 – SCWC Water System

To answer the first question, IEC has developed an inventory of the existing water system assets. This is based on existing water system records provided by the SCWC as well as the Engineering Report dated May 2019, prepared by the California Rural Water Association (CRWA). Please see **Figure 1** for a map of the existing water system facilities. To prepare the inventory, IEC reviewed the following records provided by the SCWC:

The SCWC’s sources of water are groundwater from the El Mirage Basin in the Swarthout Canyon of the San Gabriel Mountains and most recently groundwater from the Mojave Basin, Alto subarea. The SCWC has seven water supply facilities, this includes six wells and a tunnel, see **Table 2.1** for an inventory of the existing water supply sources and **Figure 1** for a map of the existing system.

The seven tanks are located at various sites and different elevations throughout the system, see **Figure 1**. Water is pumped directly from the wells into Tank 7. Tank 5 feeds from Tank 7, but it can also feed from water pumped directly from the wells through a bypass line. From this point, water flows through gravity to the rest of the system.

The SCWC water distribution system consists of approximately 73 miles of pipelines. Appurtenances include pressure regulating valves and isolation valves, there are approximately 240 dead end and in-line fire hydrants/blow offs, and approximately 1,200 service connections in the system. Refer to **Figure 1** for a map of the existing system and service area.

*Pipelines which have been installed recently and are identified by year of installation in Figure 1 are not included for replacement.
